Pipe Cleaning and CCTV Survey Report

ALCo Property

Schenectady, NY

December 2010

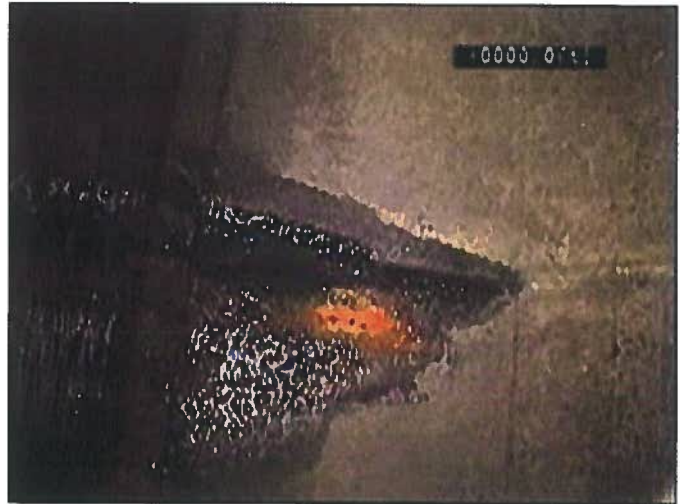
Defect Location: 8.0 ft downstream of the
Overflow Gate

Defect: Infiltration Runner

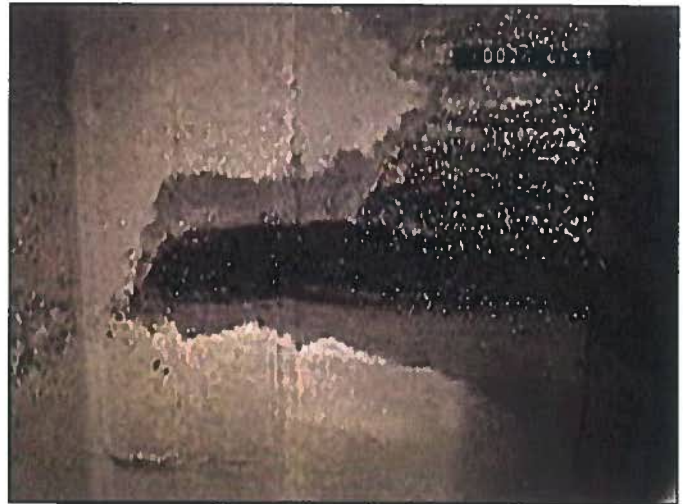
Defect Location: 24.8 ft downstream of the Overflow Gate

Defect: Infiltration Runner

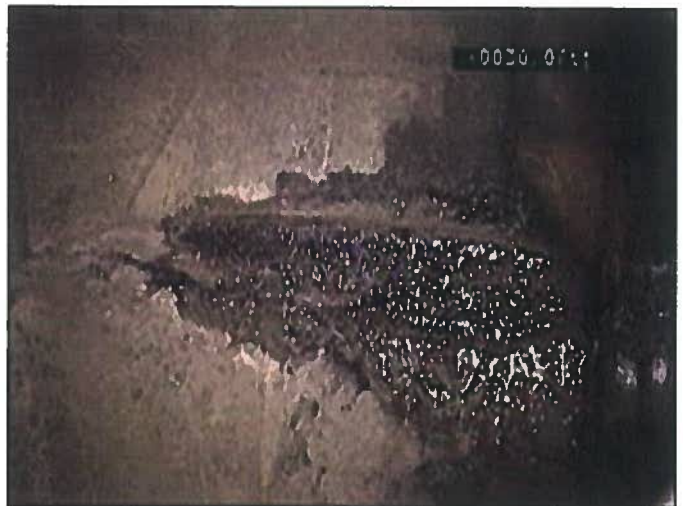
Defect Location: 38.0 ft downstream of the Overflow Gate, continuous for 156 ft

Defect: Infiltration Weeper

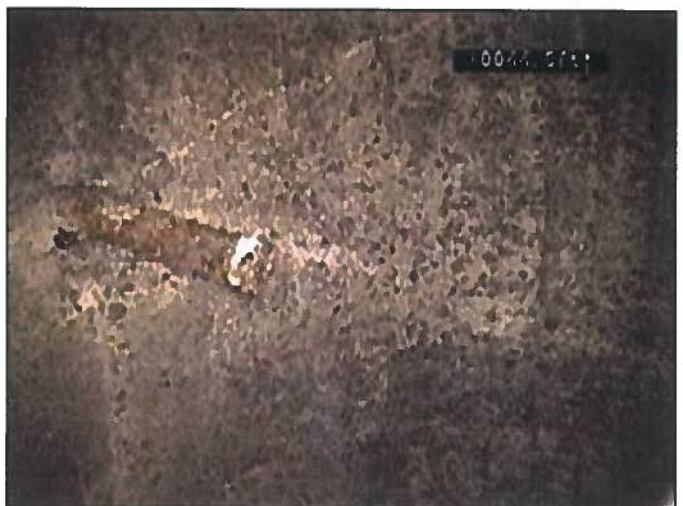
Defect Location: 46.0 ft downstream of the Overflow Gate

Defect: Tap Break-In Intruding

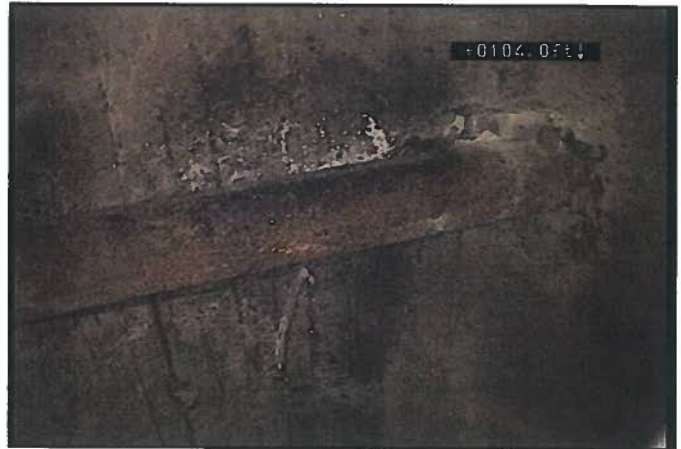
Defect: Obstacle External Pipe or Cable (5%)
Defect Location: 106.0 ft downstream of the Overflow Gate

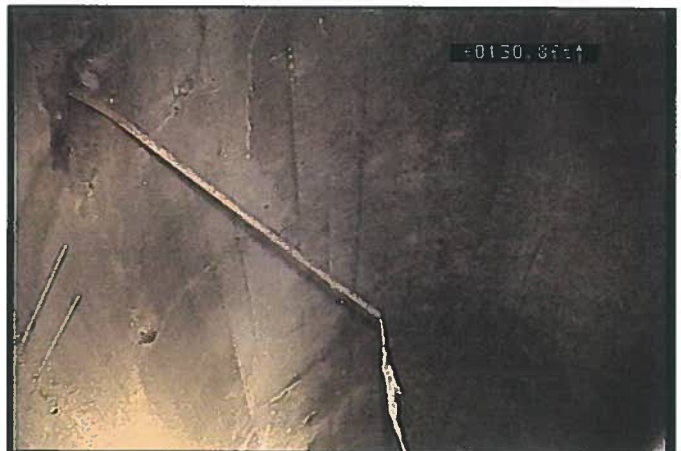
Defect: Obstacle External Pipe or Cable (5%)
Defect Location: 133.5 ft downstream of the Overflow Gate

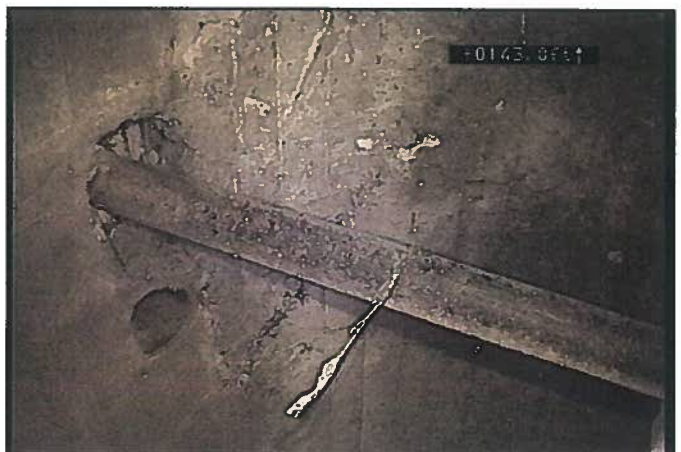
Defect: Obstacle External Pipe or Cable
Defect Location: 147.9 ft downstream of the Overflow Gate

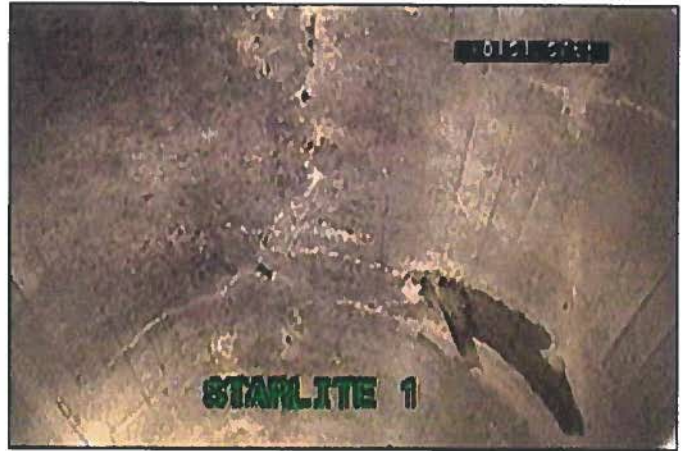
Defect Location: 151.5 ft downstream of the Overflow Gate

Defect: Crack Multiple

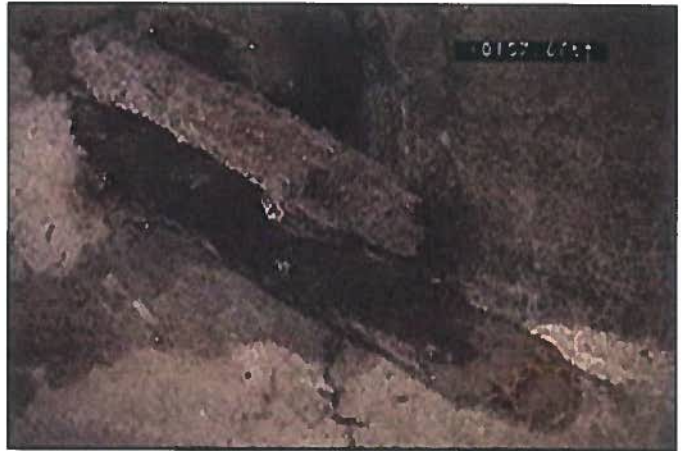
Defect Location: 157.6 ft downstream of the Overflow Gate

Defect: Tap Break-In Intruding

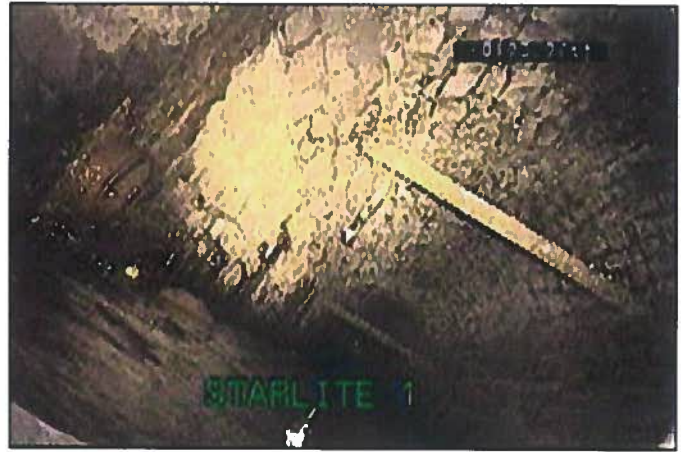
Defect: Tap Break-In Intruding
Defect Location: 201.8 ft downstream of the Overflow Gate

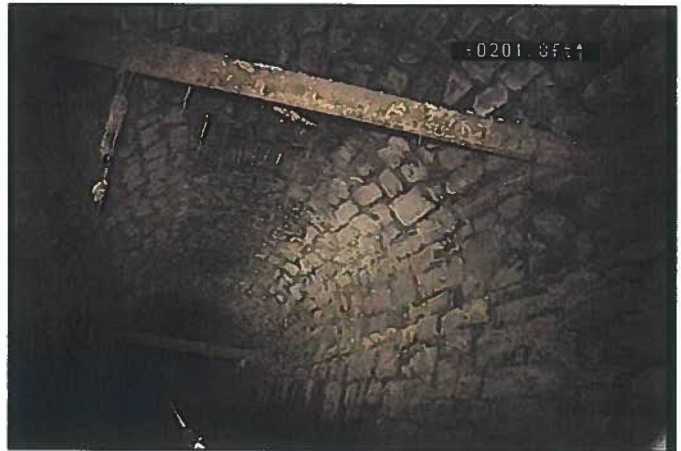
Defect: Obstacle External Pipe or Cable
Defect Location: 211.5 ft downstream of the Overflow Gate

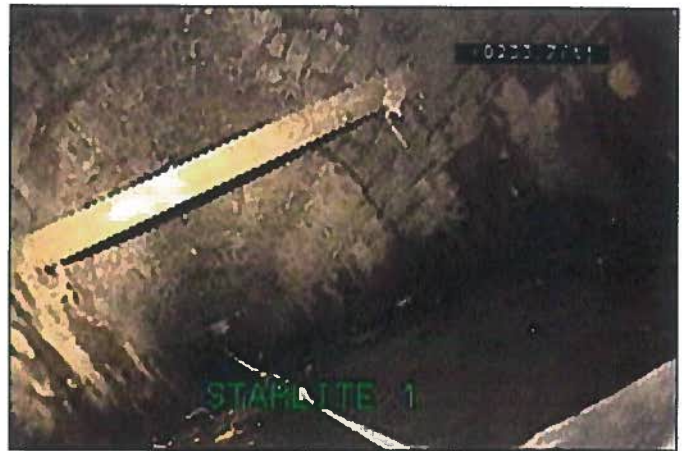
Defect: Obstacle External Pipe or Cable
Defect Location: 248.0 ft downstream of the Overflow Gate

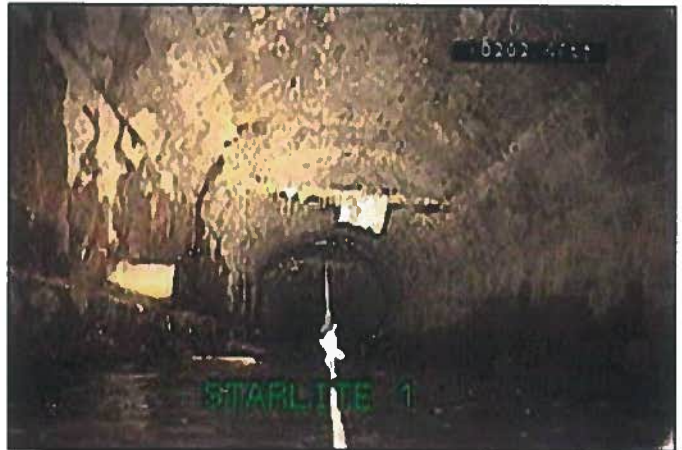
Defect: Tap Break-In Intruding
Defect Location: 292.4 ft downstream of the Overflow Gate

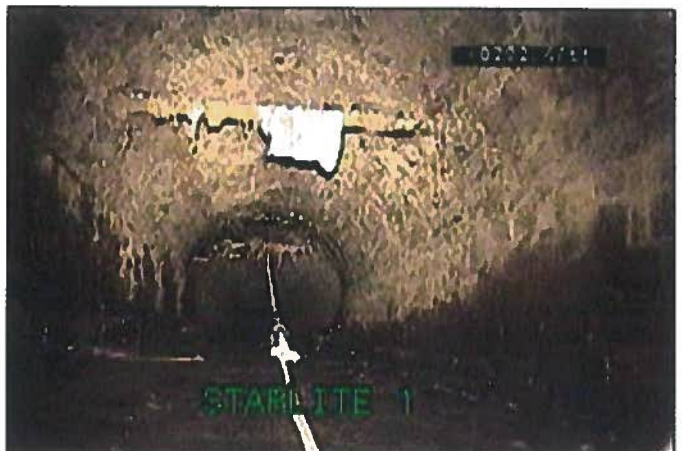
Defect: Obstacle External Pipe or Cable
Defect Location: 308.2 ft downstream of the Overflow Gate

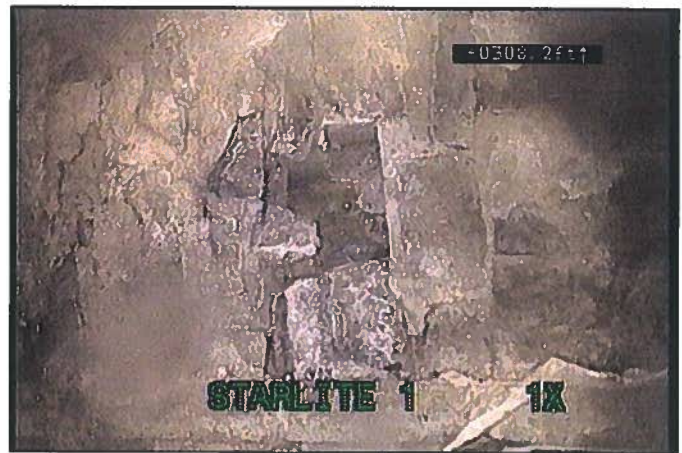
Defect Location: 308.2 ft downstream of the Overflow Gate

Defect: Missing Brick

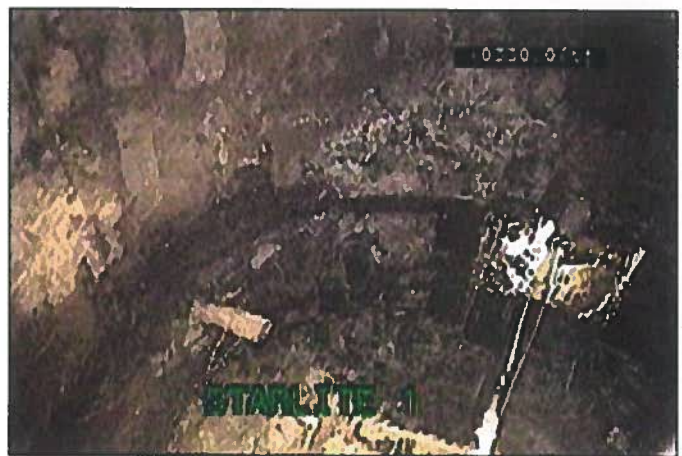
Defect Location: 330.0 ft downstream of the Overflow Gate

Defect: Tap Break-In Intruding

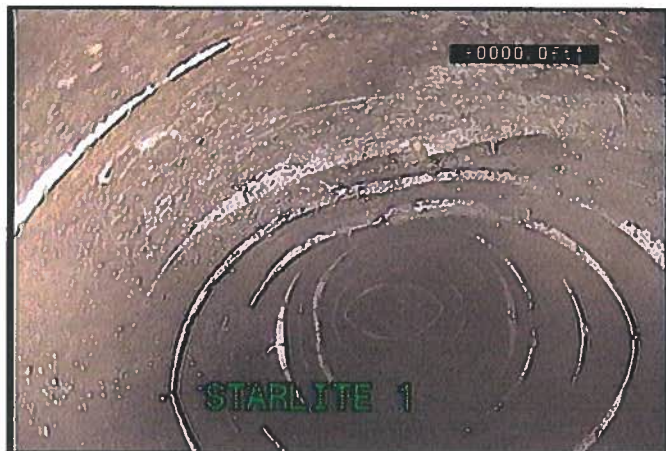
Defect: Break
Defect Location: 6.0 ft upstream of the DMH in Building 320 (abandoned survey)

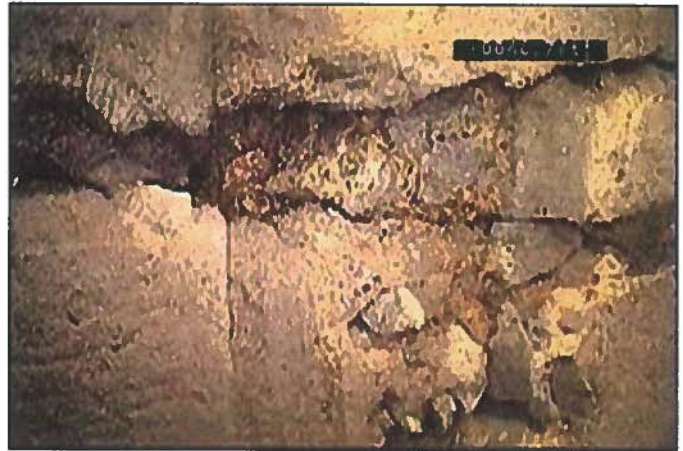
Defect: Fracture Multiple
Defect Location: 47.1 ft upstream of the
Outfall

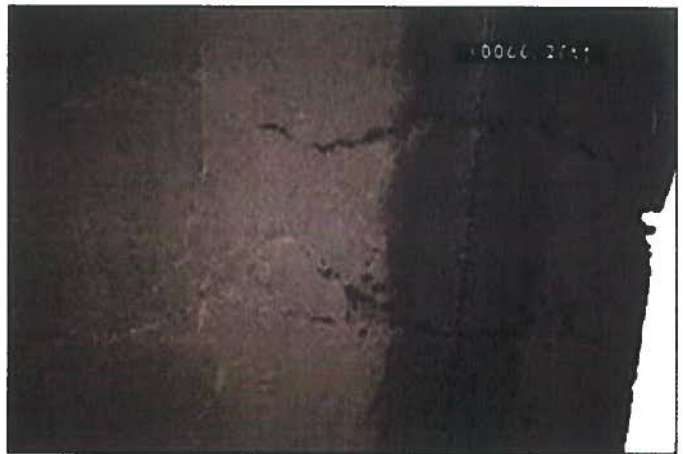
Defect: Fracture Multiple
Defect Location: 67.0 ft upstream of the
Outfall

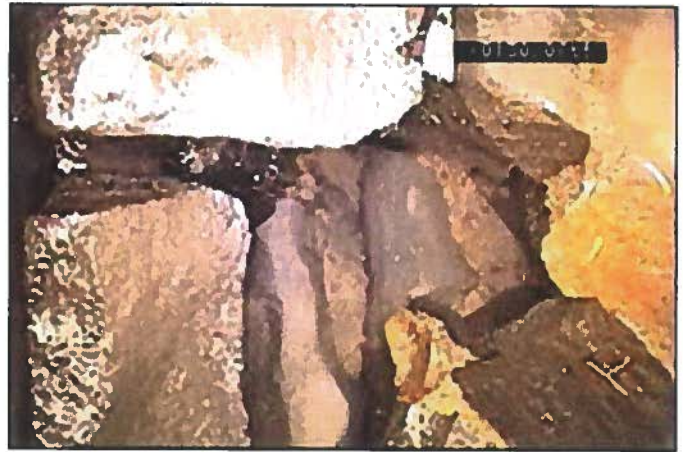
Defect Location: 138.8 ft upstream of the Outfall

Defect: Missing Brick

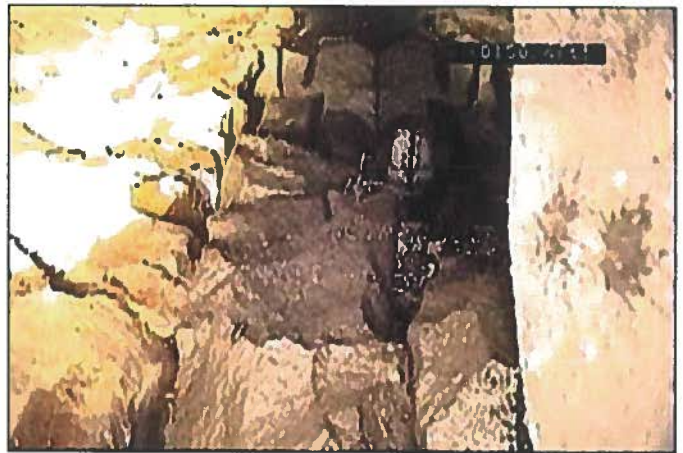
Defect Location: 158.5 ft upstream of the Outfall

Defect: Mortar Missing Large

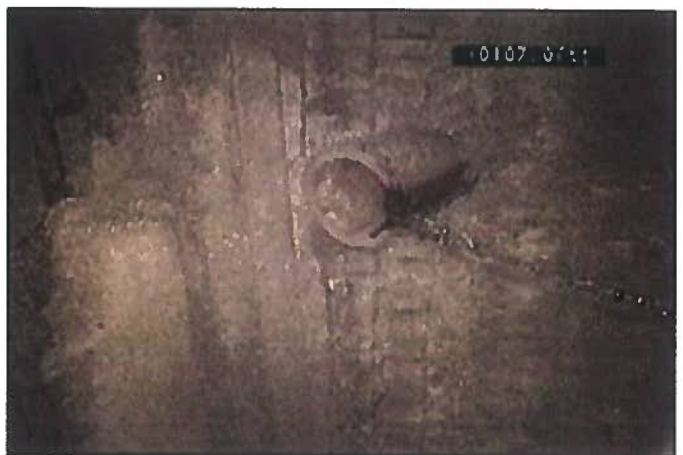
Defect Location: 187.9 ft upstream of the Outfall

Defect: Tap Break-In Intruding

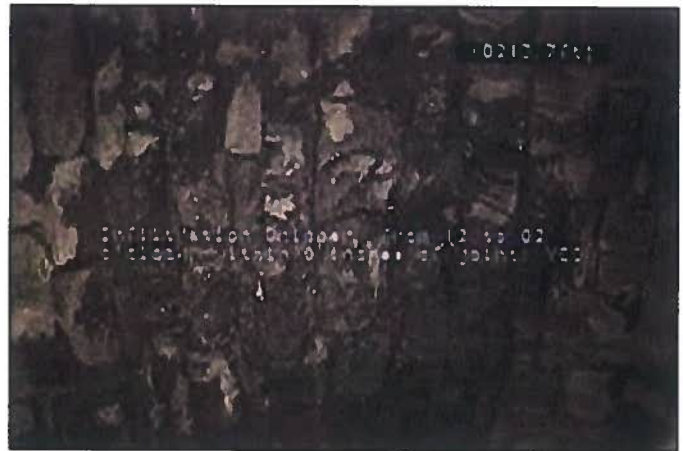
Defect: Infiltration Dripper
Defect Location: 213.7 ft upstream of the Outfall

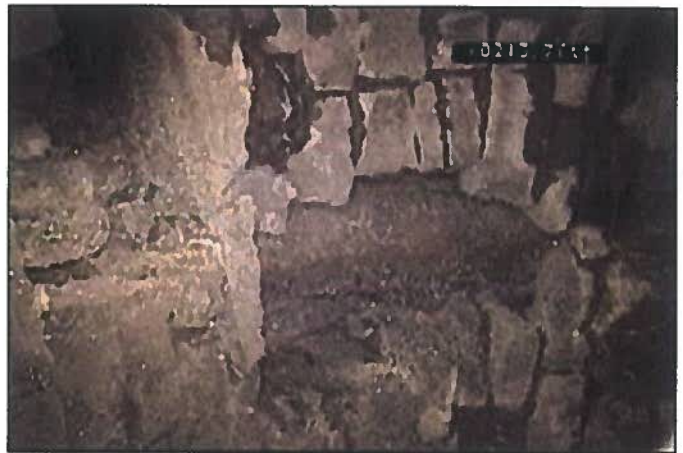
Defect: Obstacle External Pipe or Cable (5%)
Defect Location: 216.1 ft upstream of the Outfall

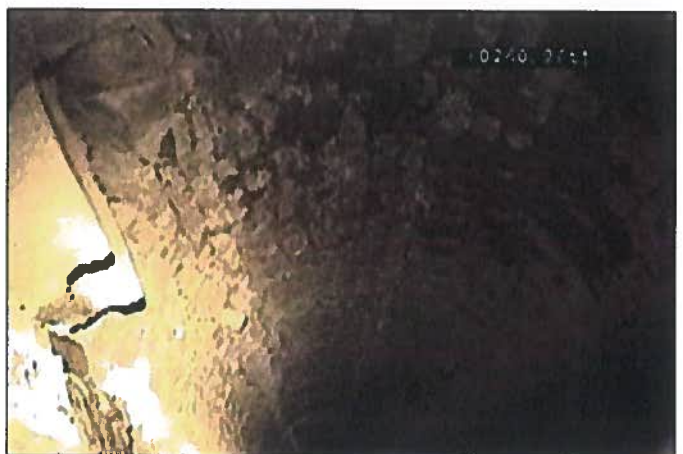
Defect: Tap Break-In Intruding
Defect Location: 255.4 ft upstream of the Outfall

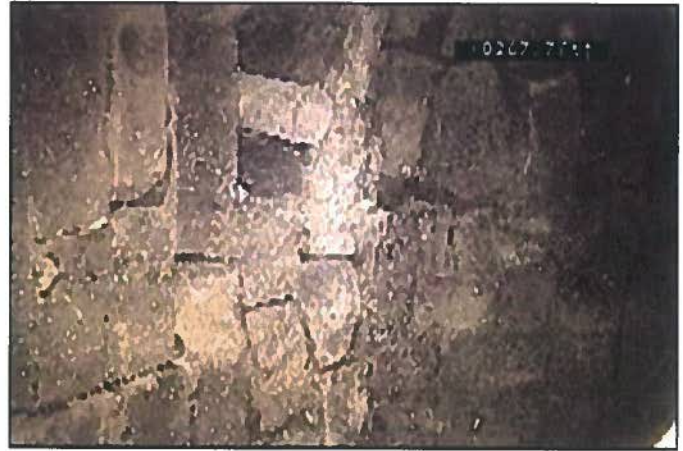
Defect: Tap Break-In Intruding
Defect Location: 267.7 ft upstream of the Outfall

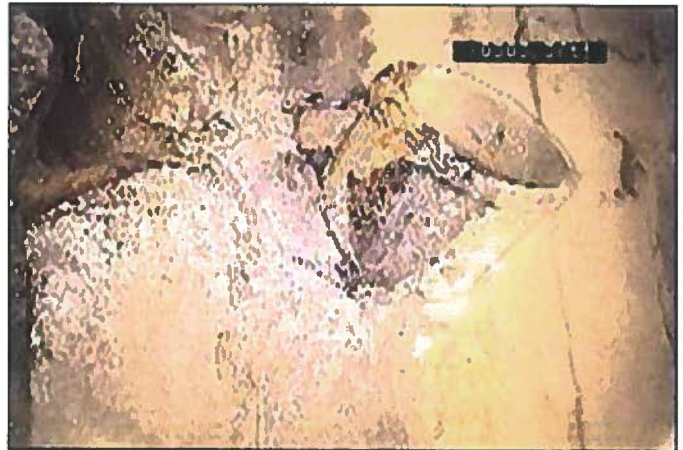
Defect: Tap Break-In Intruding
Defect Location: 303.3 ft upstream of the Outfall

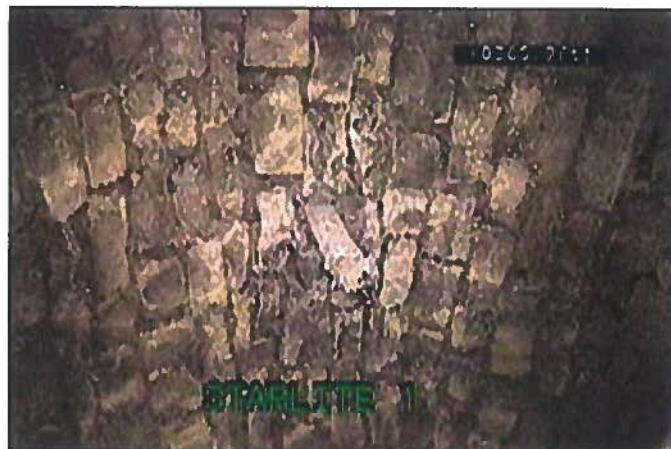
Defect: Tap Break-In Intruding
Defect Location: 369.0 ft upstream of the Outfall

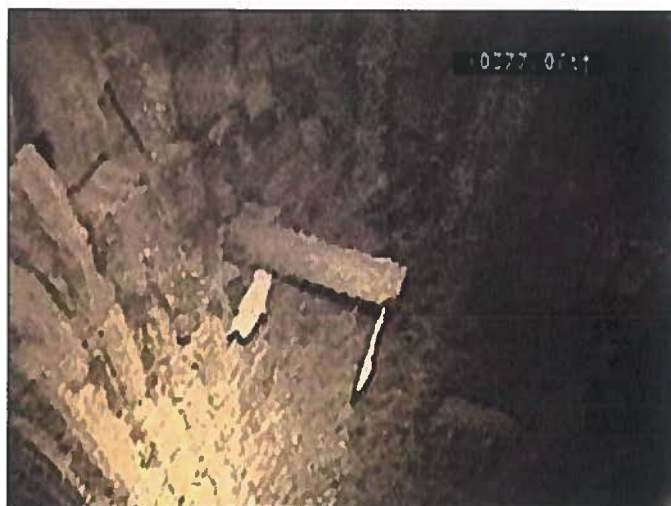
Defect: Tap Break-In Intruding
Defect Location: 380.0 ft upstream of the Outfall

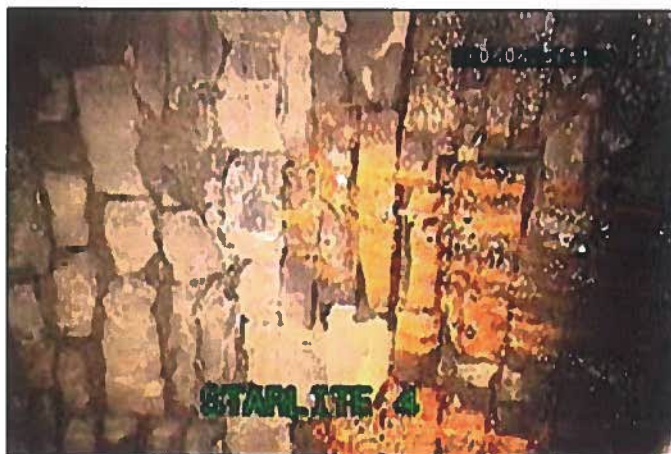
Defect: Infiltration Dripper
Defect Location: 404.5 ft upstream of the Outfall

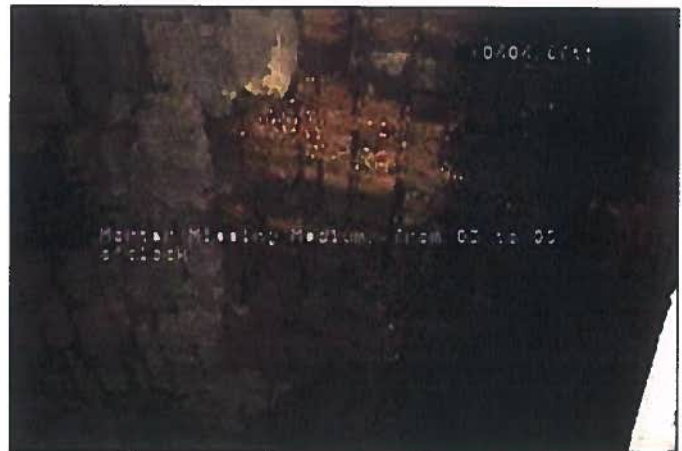
Defect: Missing Mortar Medium
Defect Location: 404.6 ft upstream of the Outfall

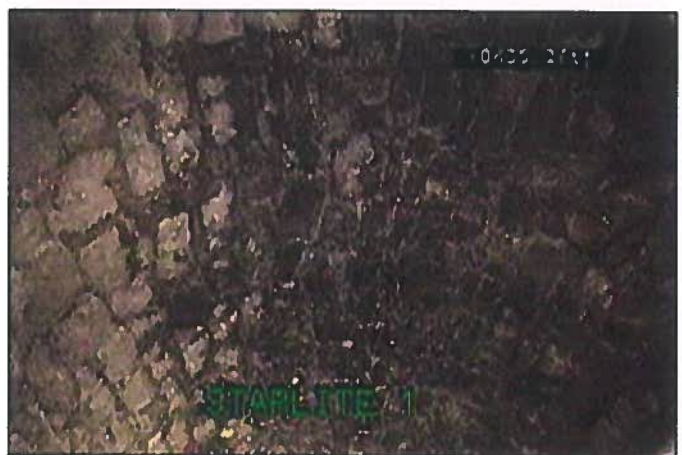
Defect: Tap Break-In Intruding
Defect Location: 435.3 ft upstream of the Outfall

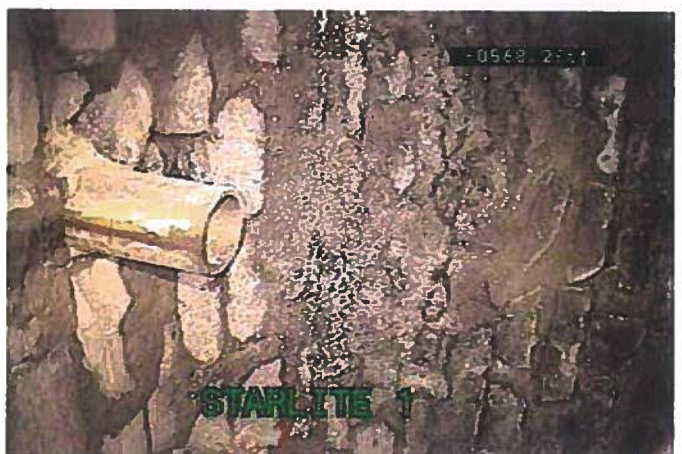
Defect: Tap Break-In Intruding
Defect Location: 568.6 ft upstream of the Outfall

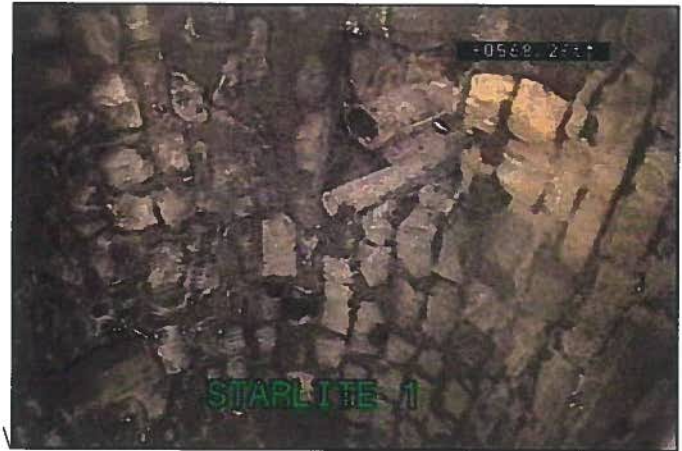
Defect: Tap Break-In Intruding
Defect Location: 574 ft upstream of the Outfall

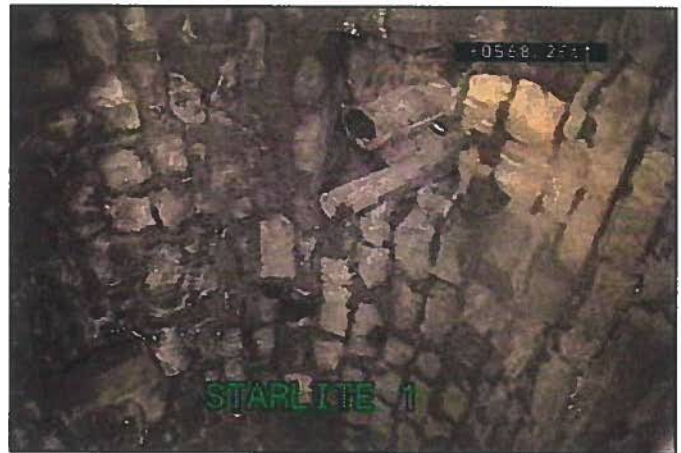
Defect: Tap Break-In Intruding
Defect Location: 575.0 ft upstream of the Outfall

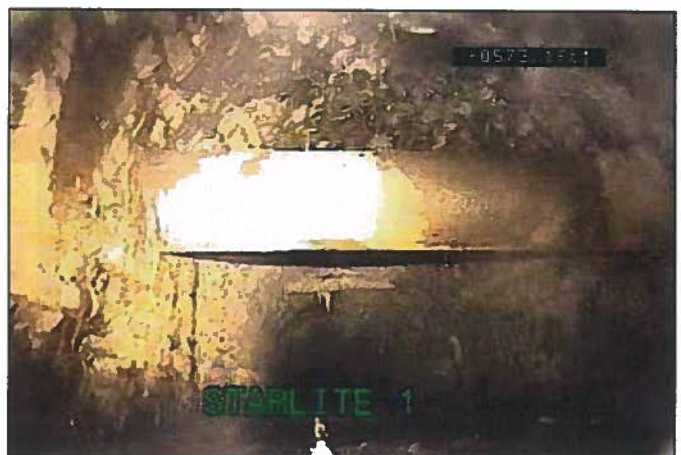
Defect: Obstacle External Pipe or Cable (10%)
Defect Location: 586.0 ft upstream of the Outfall

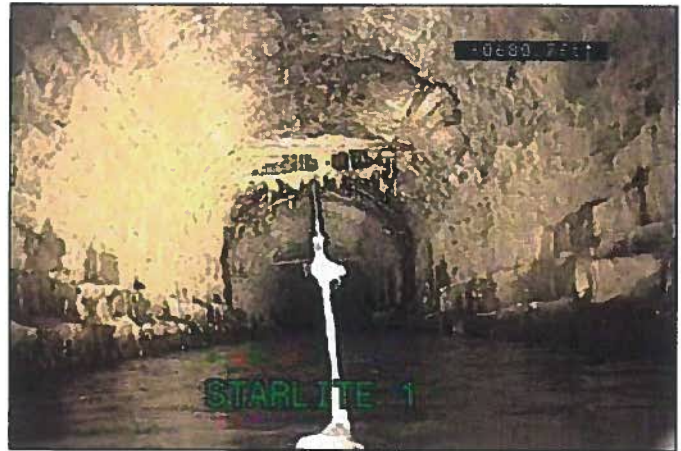
Defect: Tap Break-In Intruding
Defect Location: 690.0 ft upstream of the Outfall

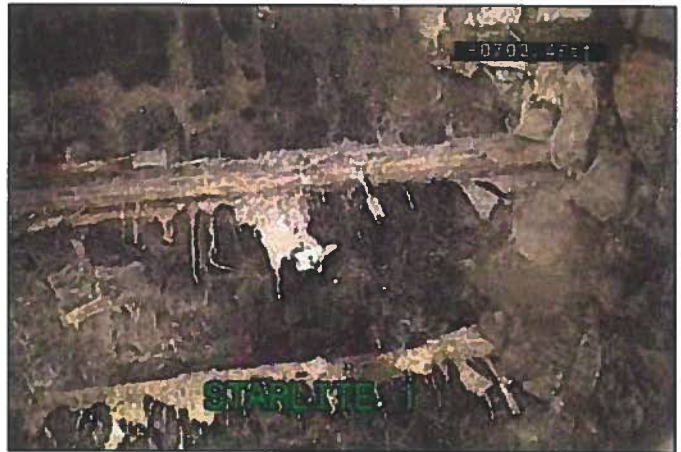
Defect: Obstacle External Pipe or Cable
Defect Location: 709.0 ft upstream of the Outfall

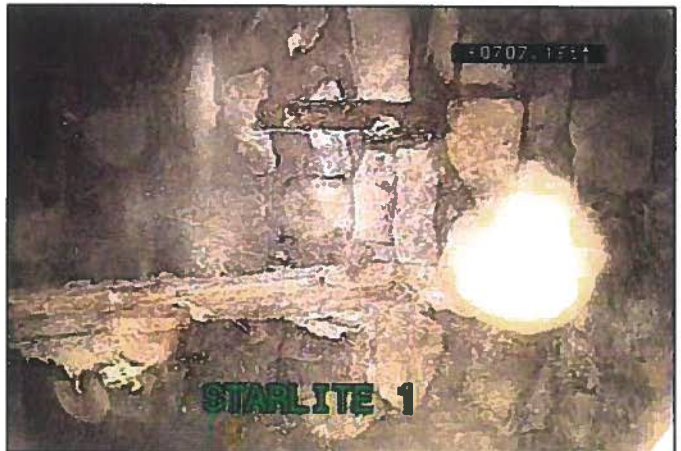
Defect: Tap Break-In Intruding
Defect Location: 709.0 ft upstream of the Outfall

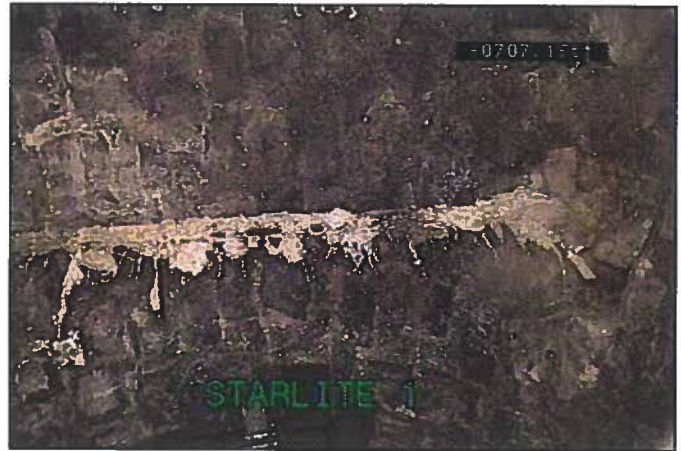
Defect: Obstacle External Pipe or Cable
Defect Location: 710.6 ft upstream of the
Outfall
