APPENDIX A
PHOTOGRAPHS

APPENDIX A-1
PHASE I ESA PHOTOGRAPHS

APPENDIX A-2
TEST PIT INVESTIGATION PHOTOGRAPHS
(MAY 13, 2014)

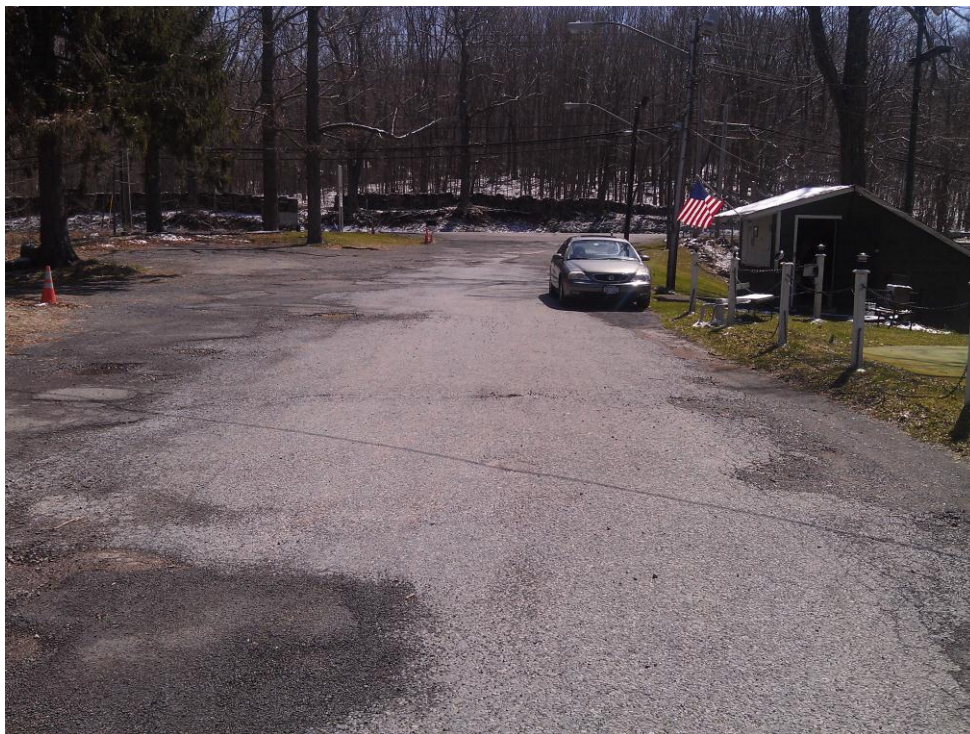
Photograph 1: Fairway Drive and Cassidy's Driving Range. View from west to east.

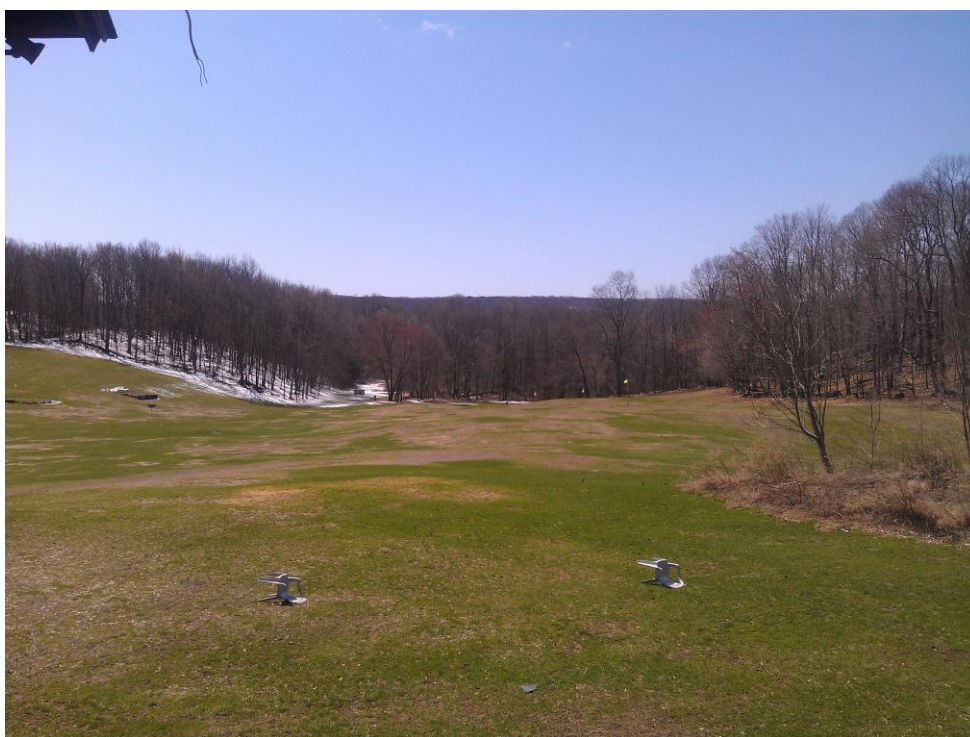
Photograph 2: Cassidy's Driving Range. View from north to south.

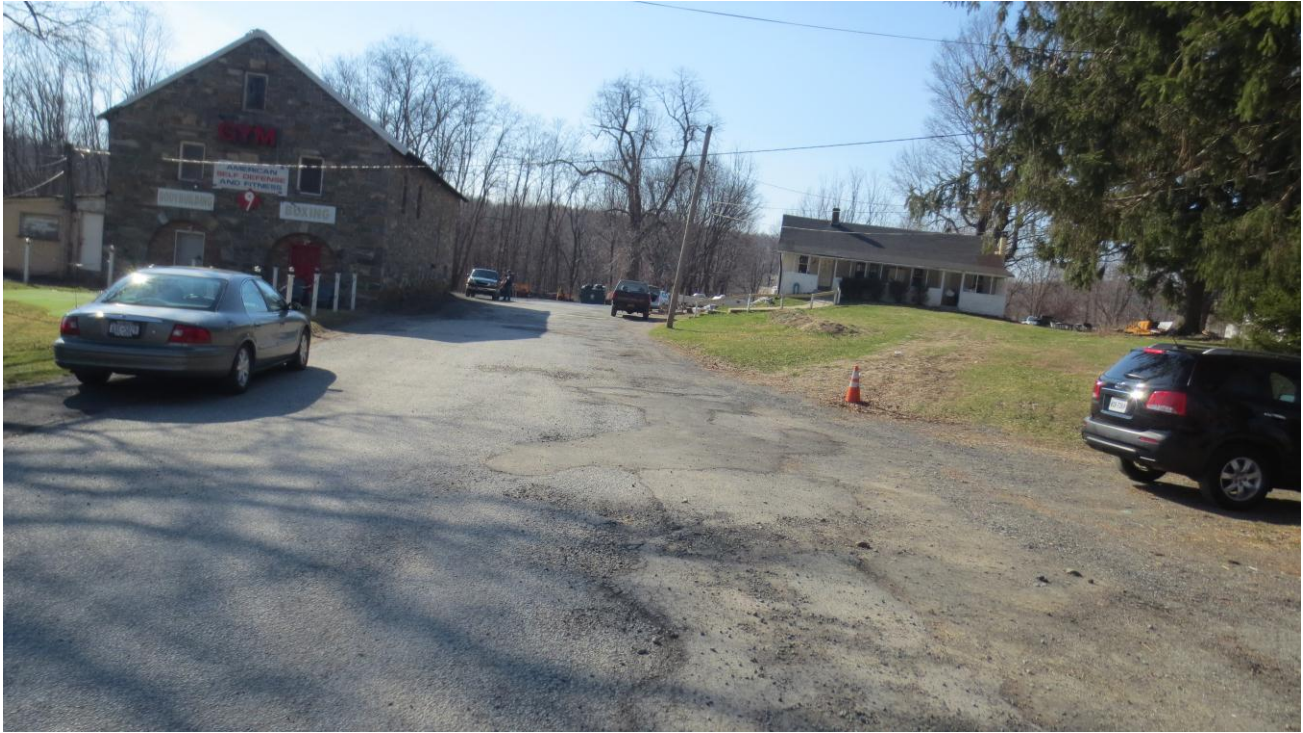
Photograph 3: Fairway Drive, stone barn, and McLaughlin residence. View from east to west.

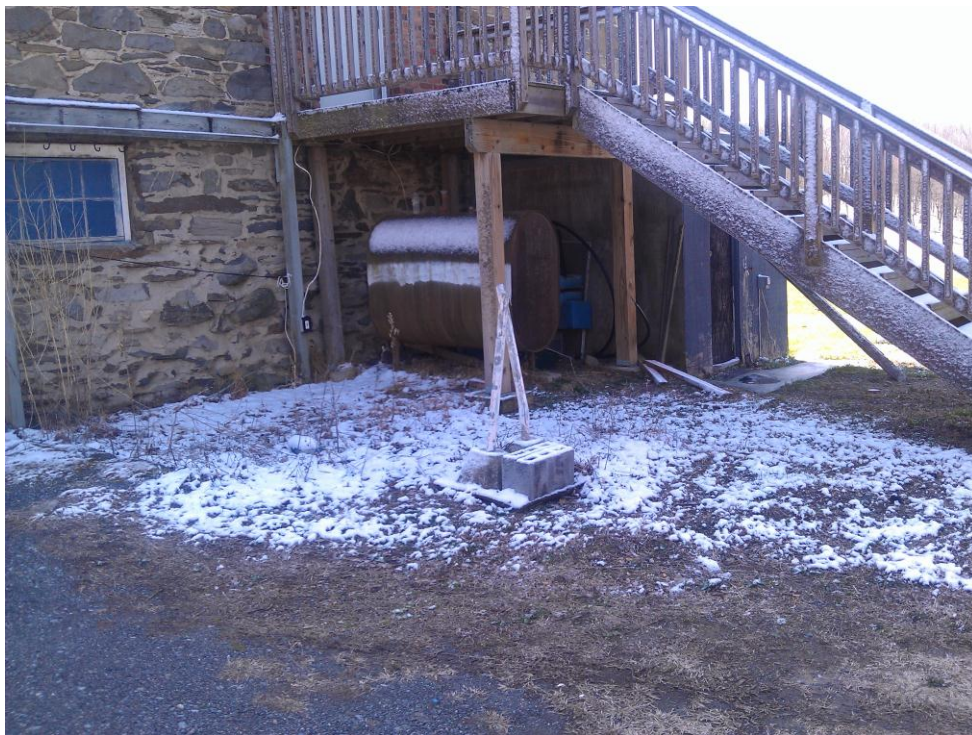
Photograph 4: View of empty heating oil AST west of stone barn (Parcel #1). View from north-northwest to south-southeast.

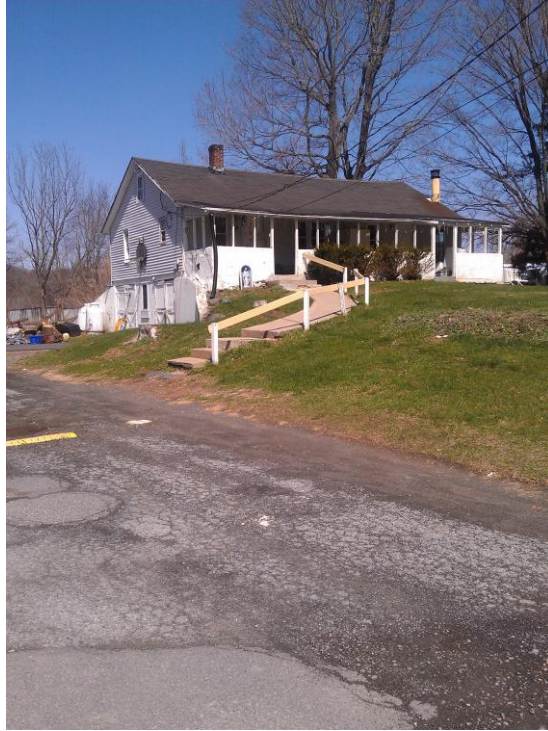
Photograph 5: McLaughlin residence. View from southeast to northwest.

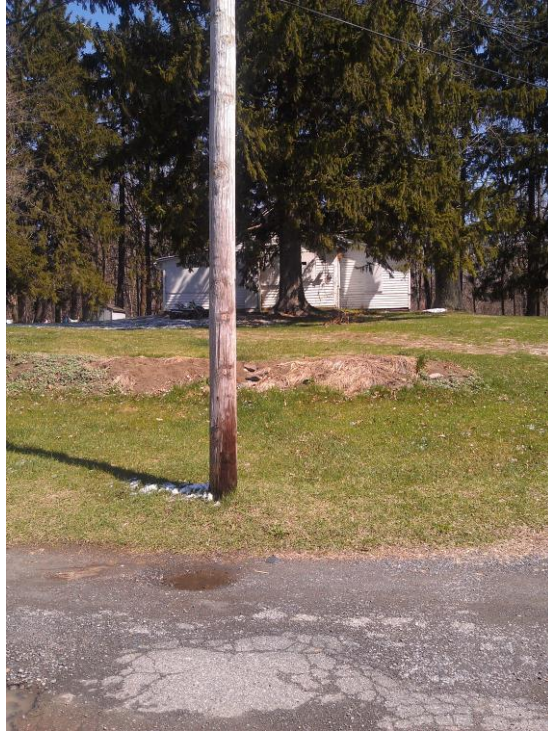
Photograph 6: Condemned, vacant residential dwelling. View from south to north.

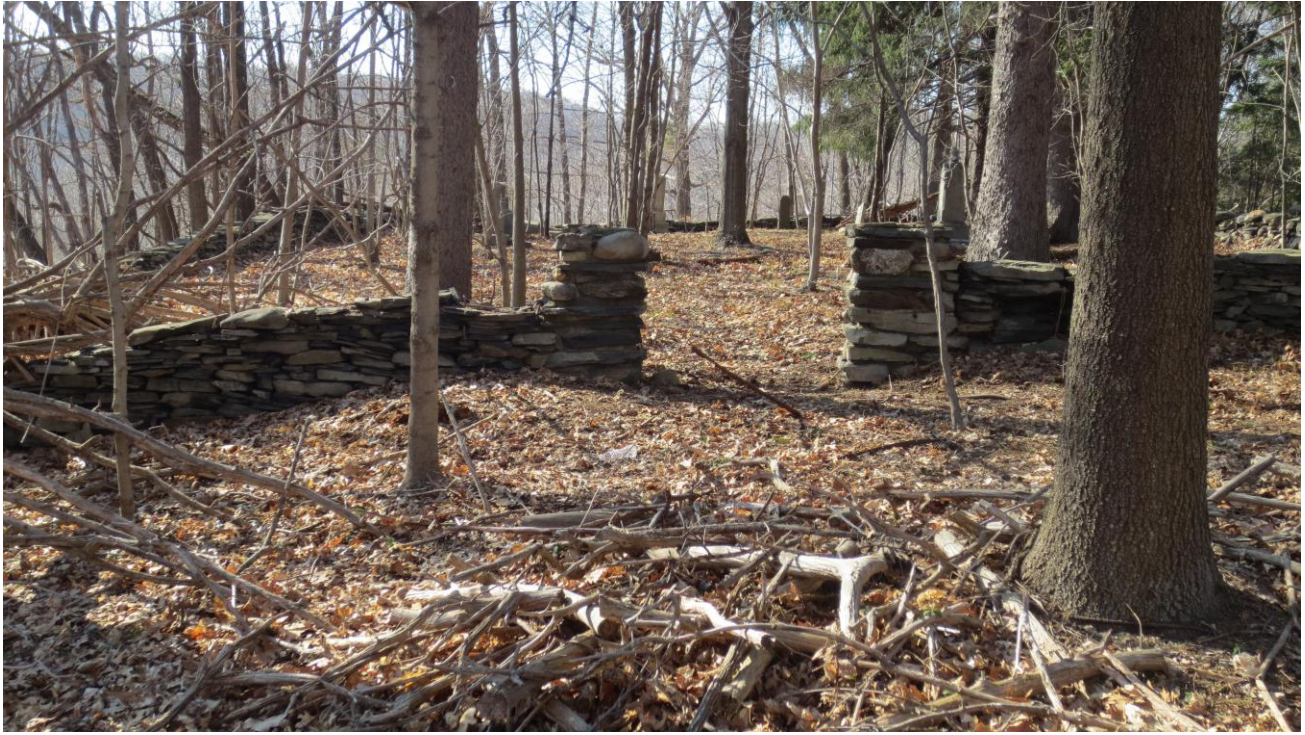
Photograph 7: Bull Family Cemetery. View from east to west.

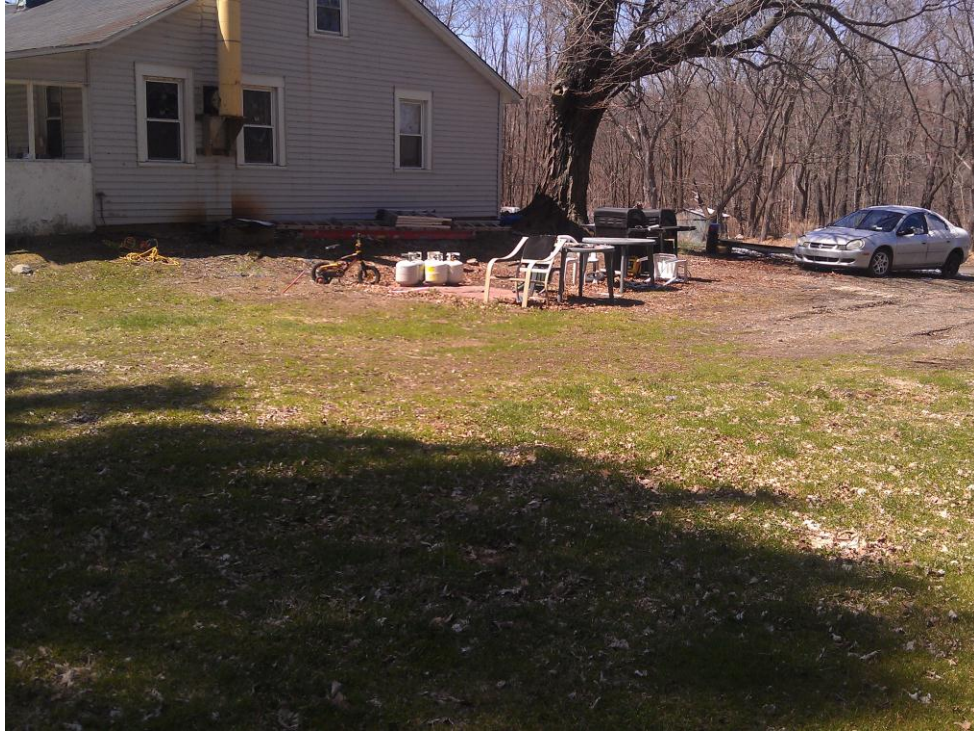
Photograph 8: Exterior north of McLaughlin residence. View from northeast to southwest.

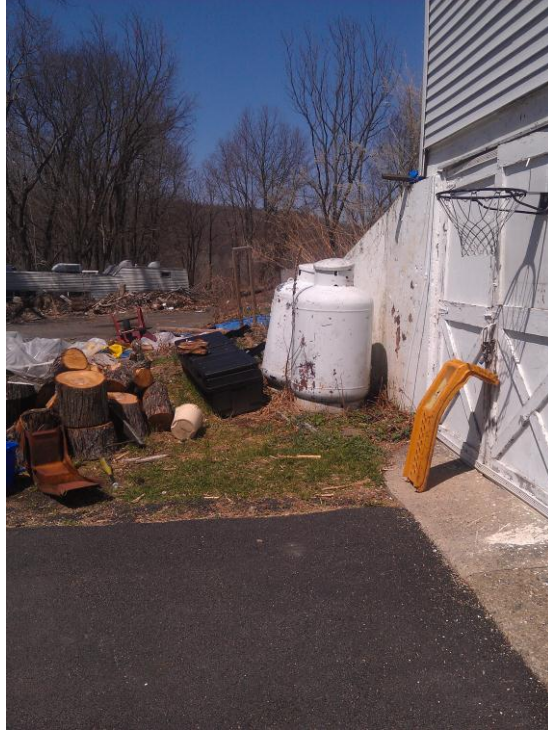
Photograph 9: Exterior south of McLaughlin residence. View from east to west.

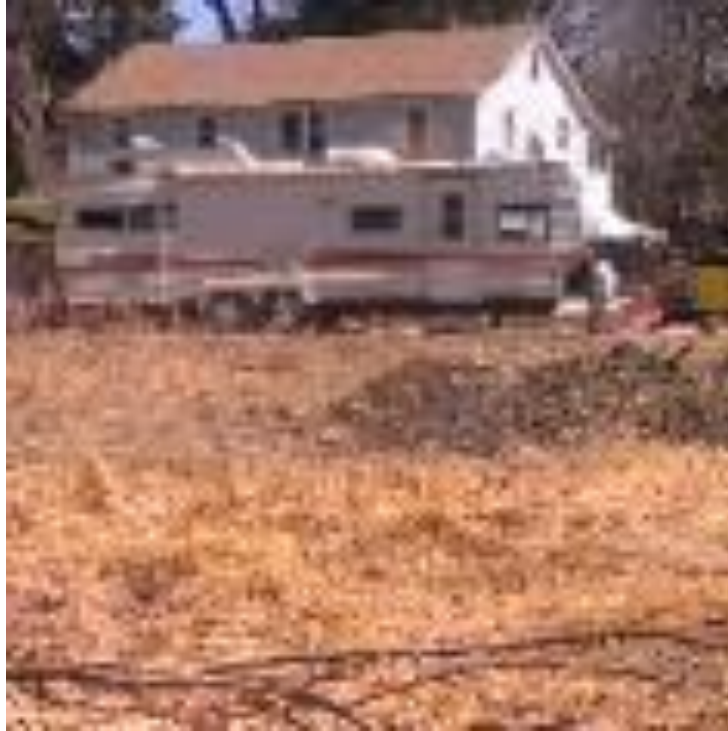
Photograph 10: Area west of Fairway Drive near southern edge of permitted sand and gravel mine. View from west to east.

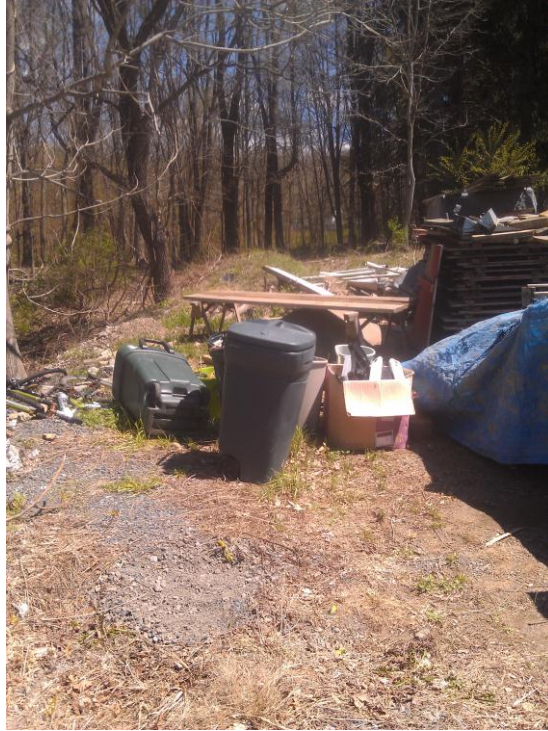
Photograph 11: View of contractor supplies stored north of Jerry Medina and Sons occupied staging area (southeastern portion of permitted mine). View from west to east.

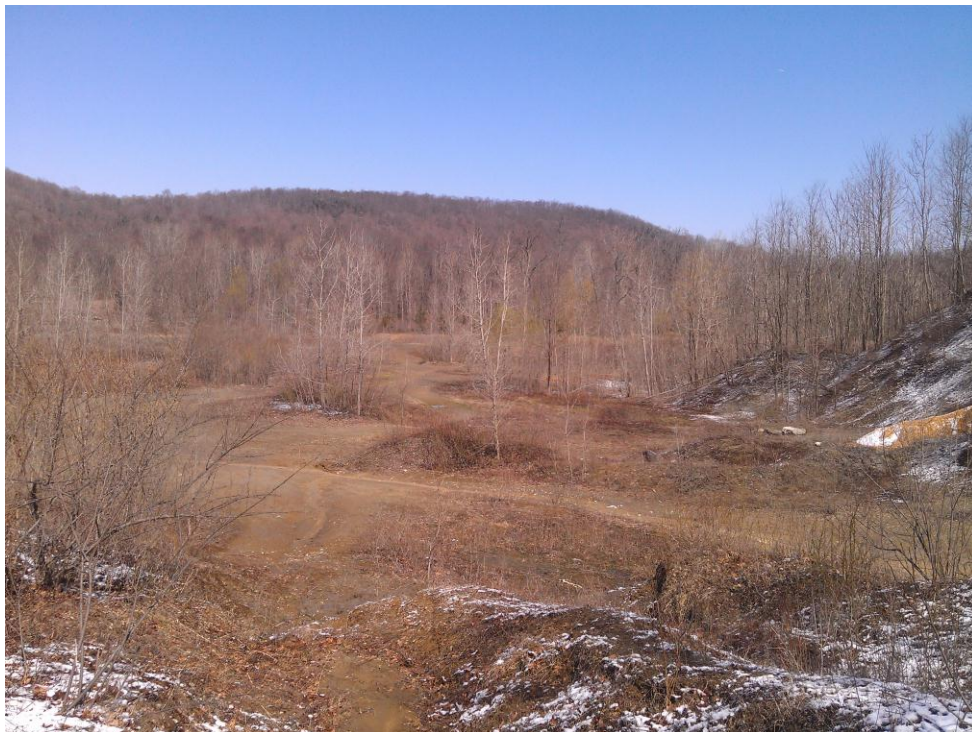
Photograph 12: Permitted sand and gravel mine (Parcel #1). View from southeast to northwest.

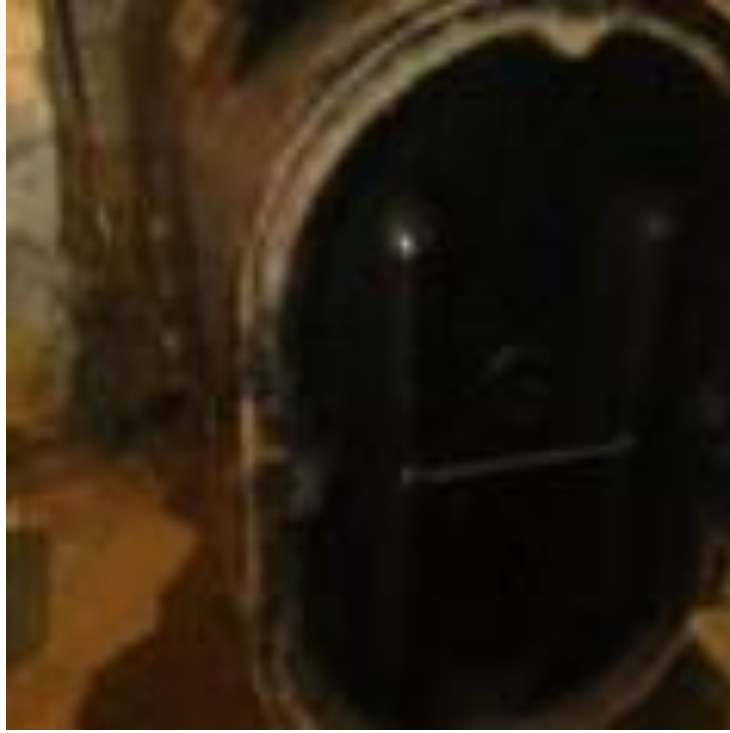
Photograph 13: View of heating oil AST in basement of Caruso residence (Parcel #1). View from south to north.

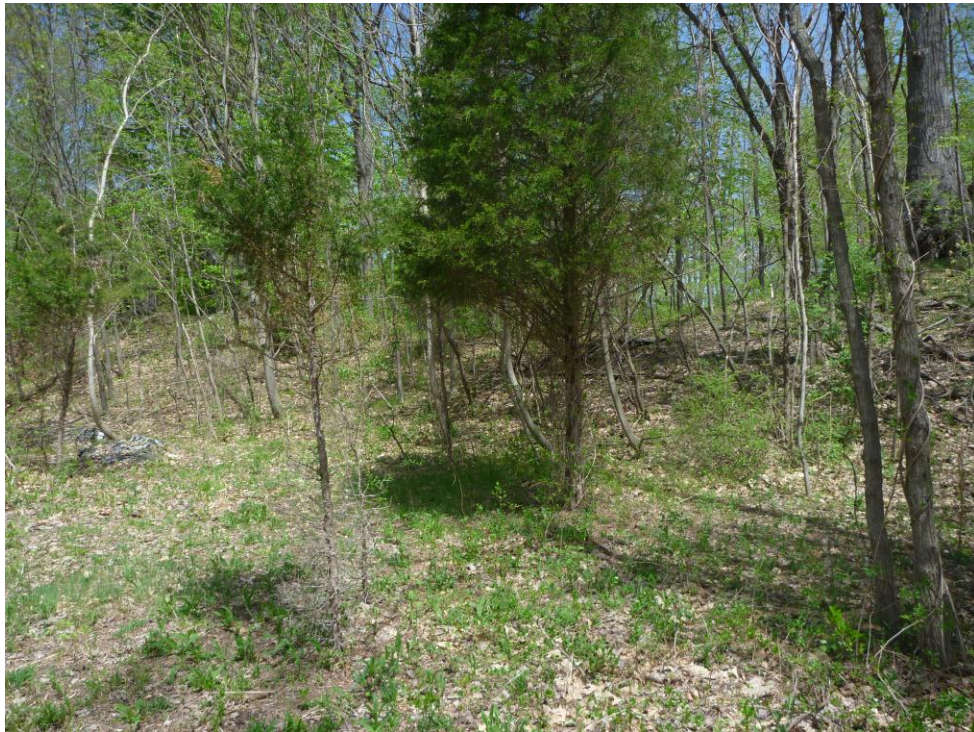
Photograph 14: Debris pile 4 (Parcel #1) of roofing waste. View from south to north.

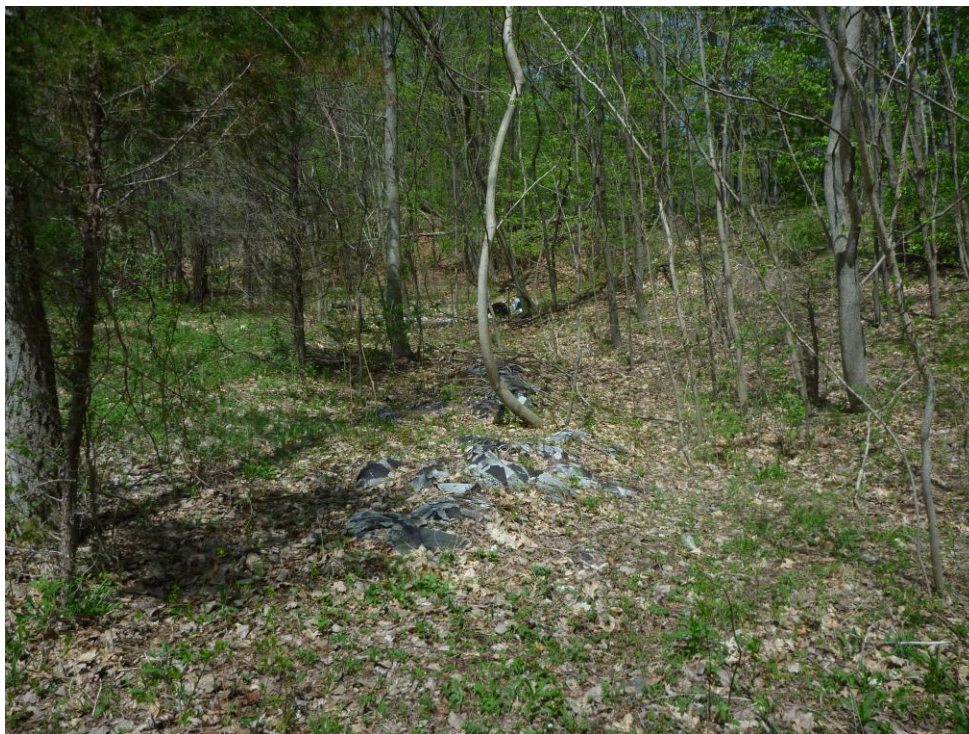
Photograph 15: Debris pile 4 (Parcel #1) of roofing waste. View from south to north.

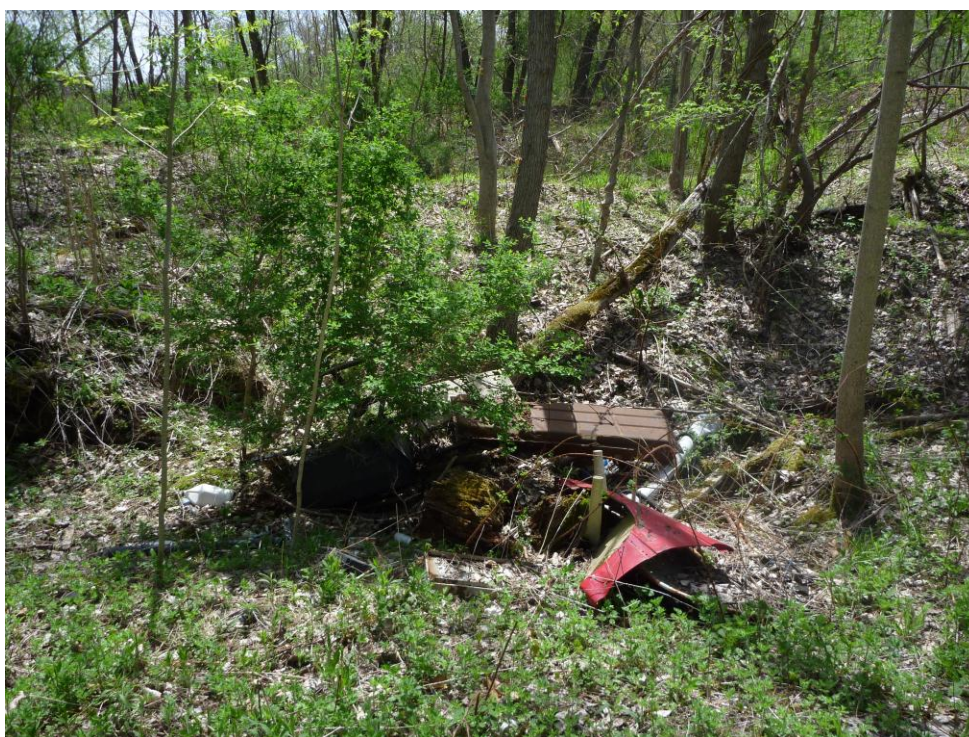
Photograph 16: Debris pile #6 (Parcel #1) including scrap metal, plastic and metal debris, and a red truck fender. View from east to west.

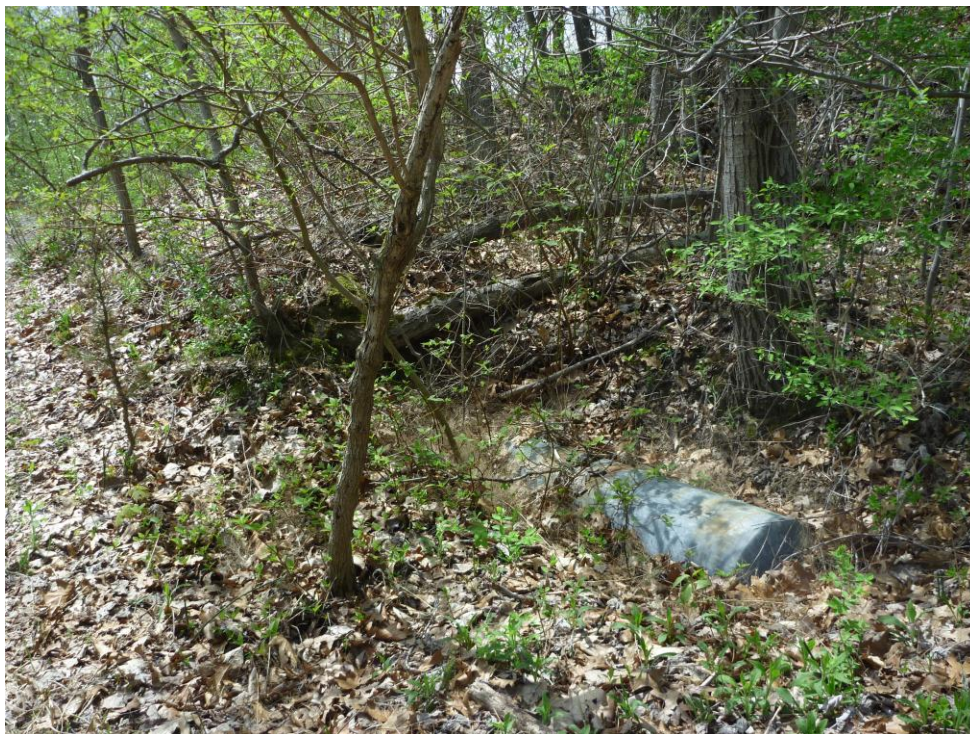
Photograph 17: Debris pile #7 (Parcel #1), containing a buried water tank. View from south to north.

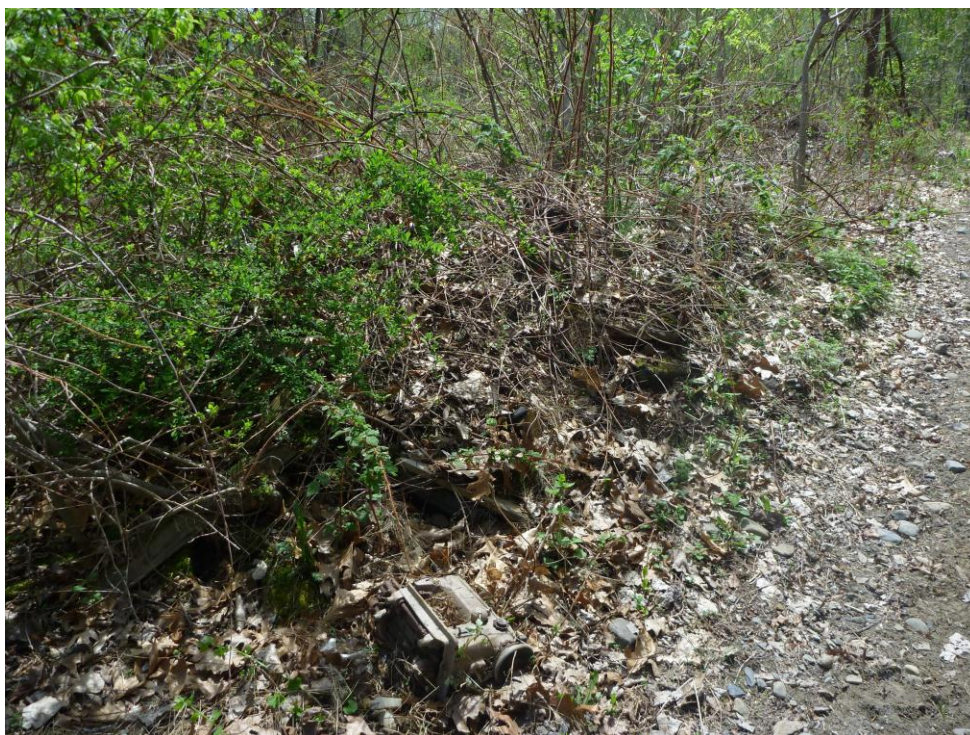
Photograph 18: Debris Pile #8 (Parcel #1). View from west to east.

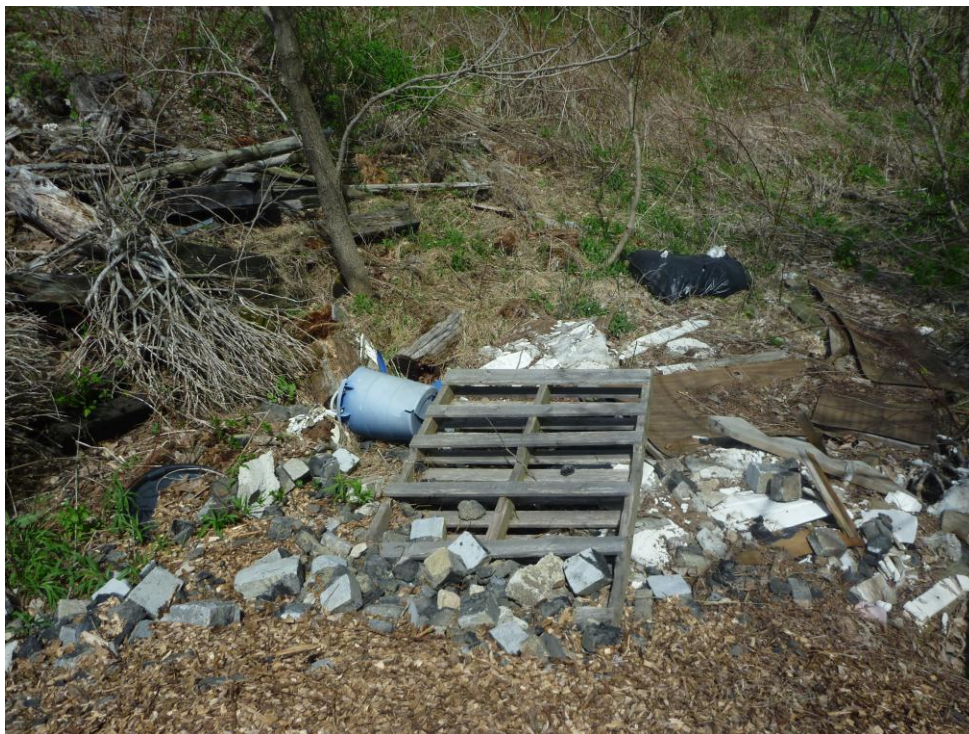
Photograph 19: View of Debris Pile #9 (Parcel #1), containing roofing waste, tires, concrete chunks, etc. View from north to south.

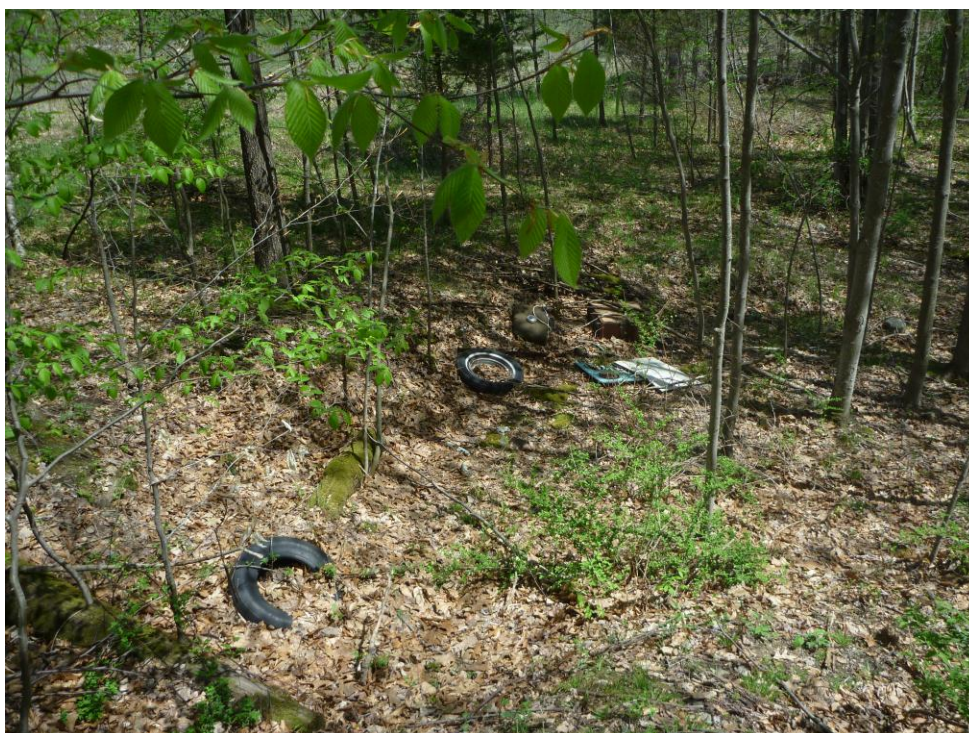
Photograph 20: Debris pile #10, containing tires and miscellaneous debris. View from north to south.

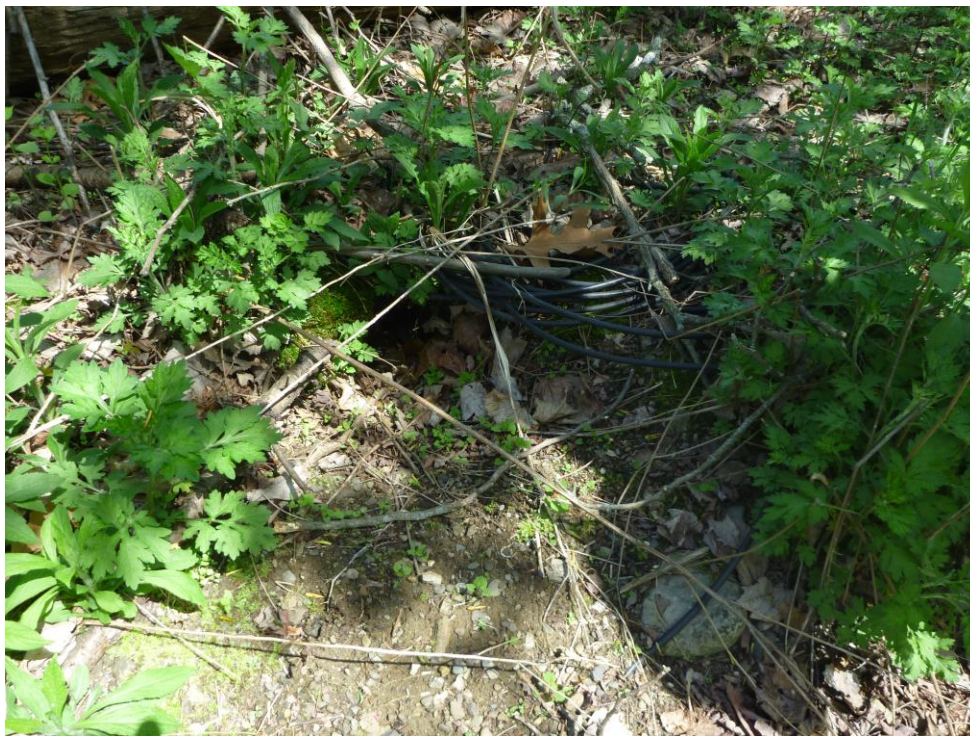
Photograph 21: Debris pile #11, containing flexible black pipe. View from east to west.

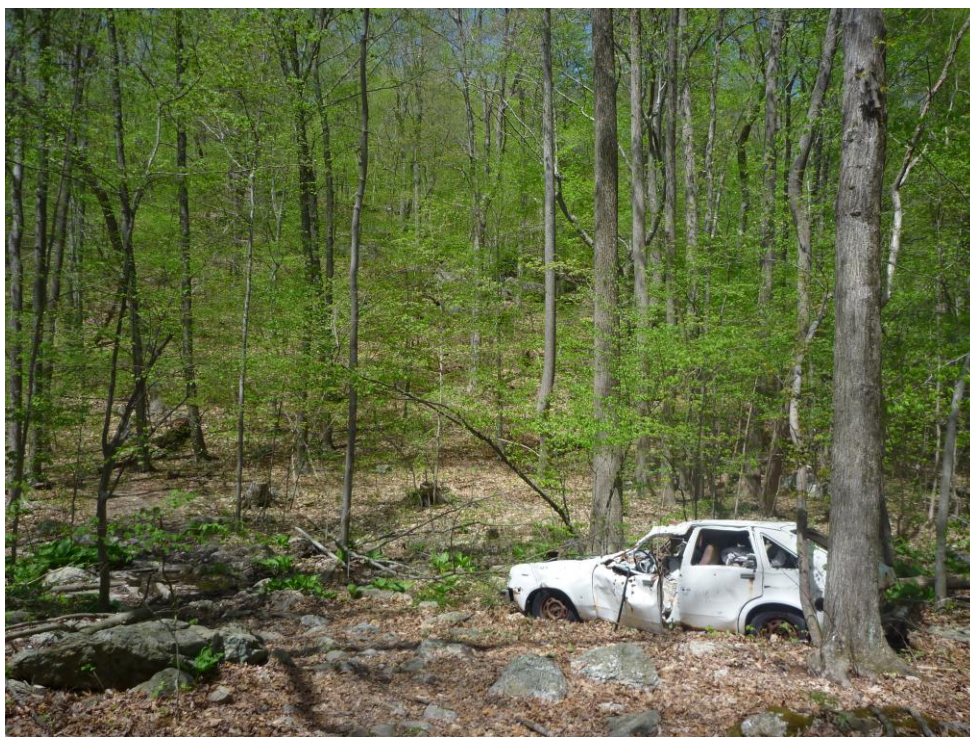
Photograph 22: View of debris pile #13, abandoned vehicle west of Satterly Creek (Parcel #1). View from southwest to northeast.

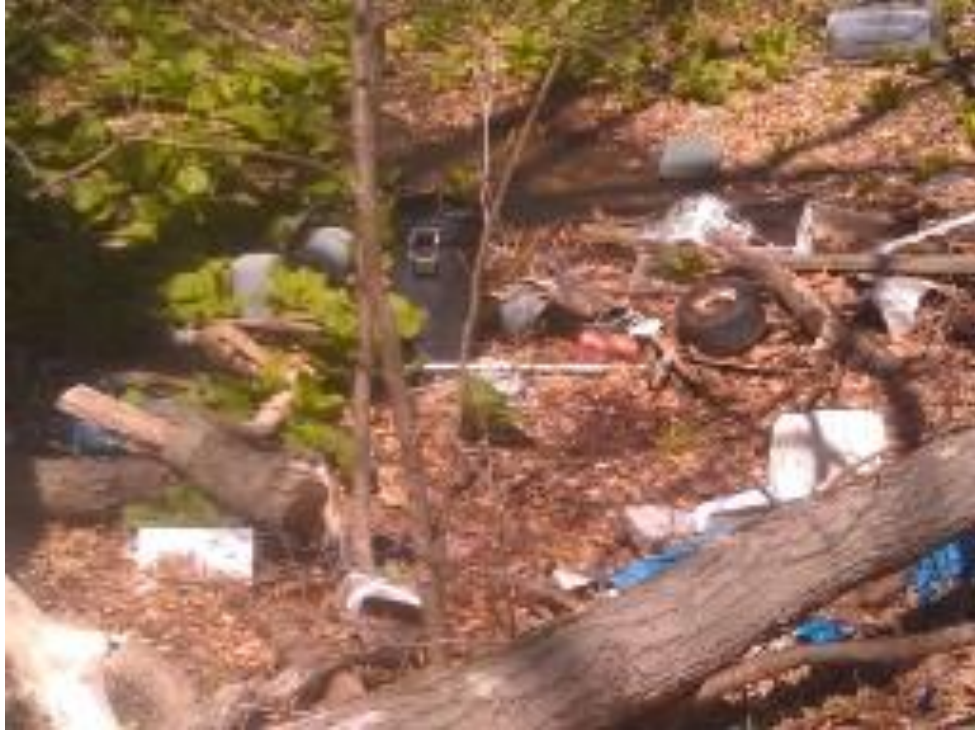
Photograph 23: Debris Pile #14 west of pond in southwestern portion of Parcel #1. View from south to north.

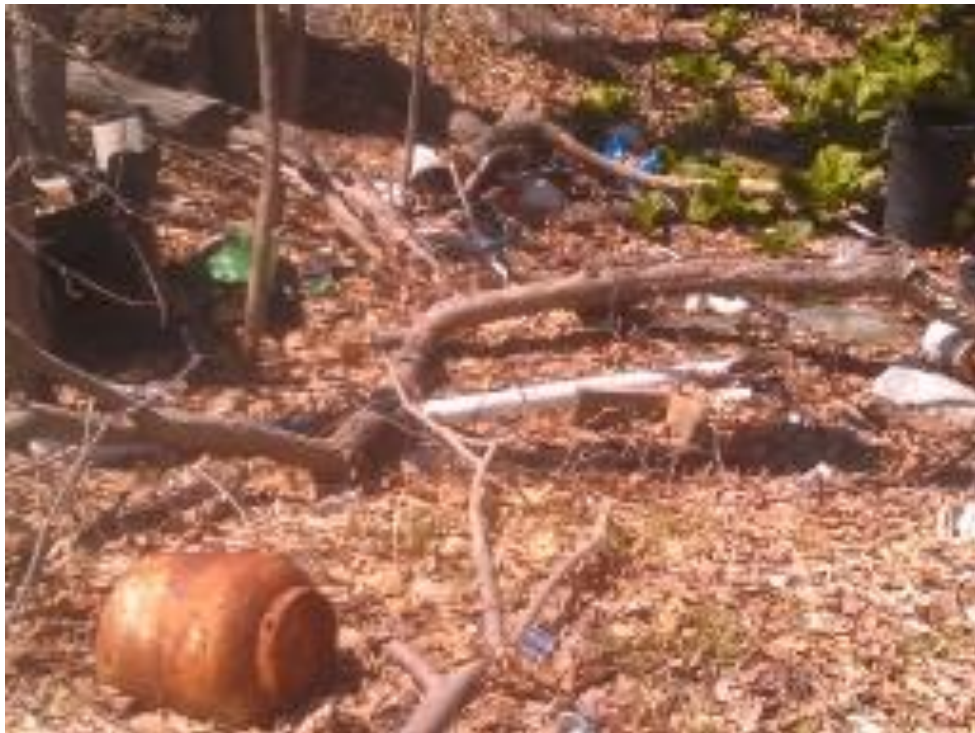
Photograph 24: Debris Pile #14 west of pond in southwestern portion of Parcel #1. View from southeast to northwest

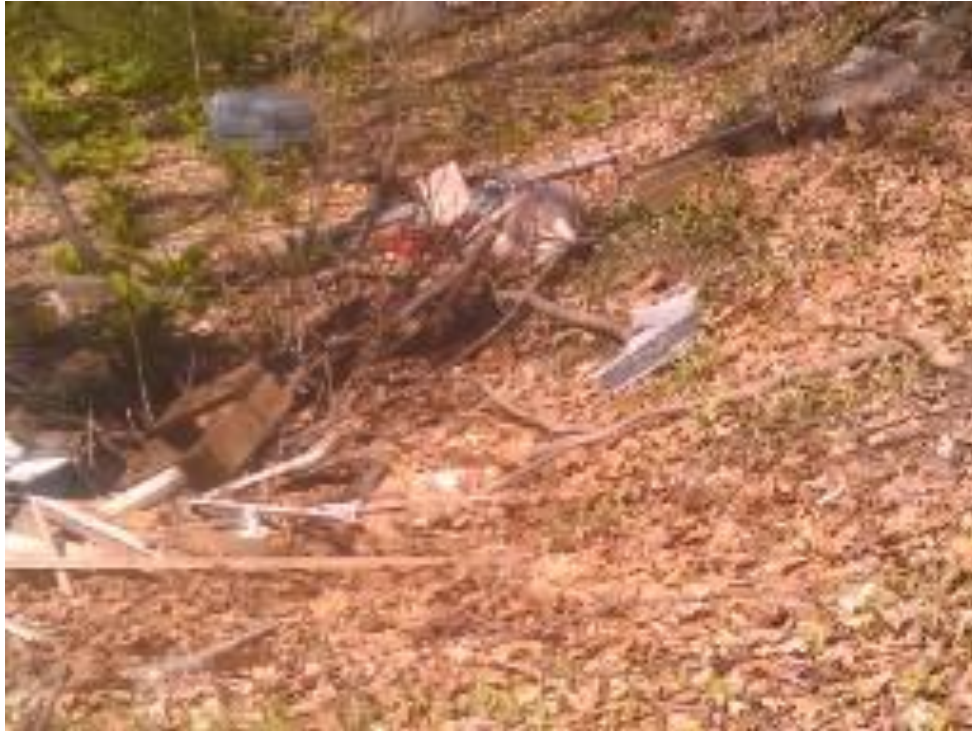
Photograph 25: Debris Pile #14 west of pond in southwestern portion of Parcel #1. View from south to north.

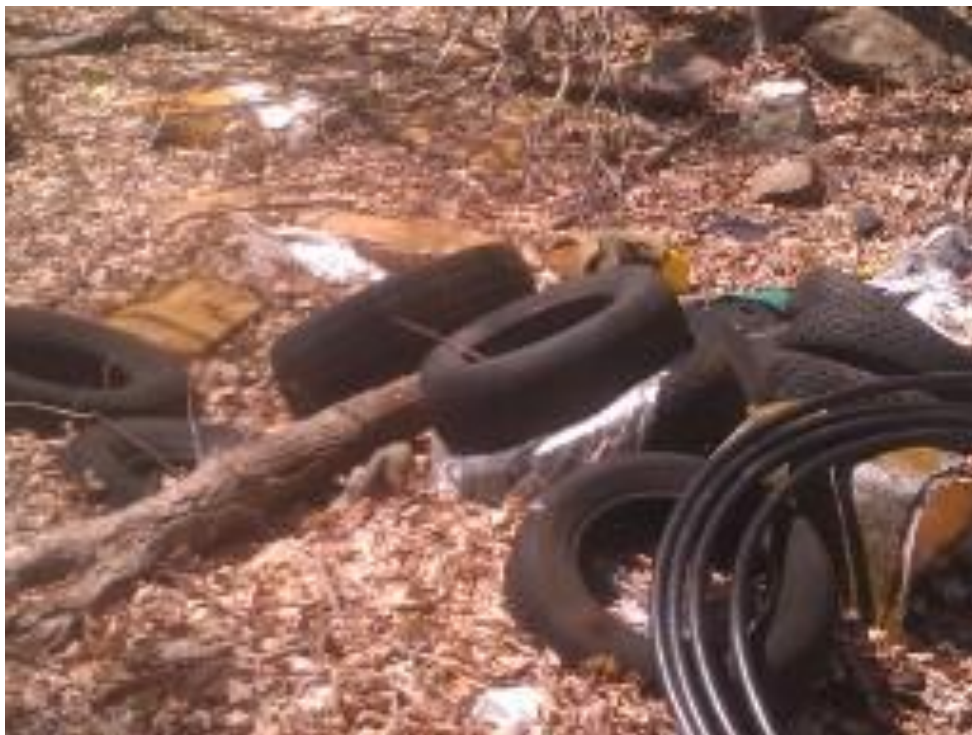
Photograph 26: Debris pile #1, containing tires and black flexible pipe south of Caruso residence along northern perimeter of Parcel #2. View from east to west.

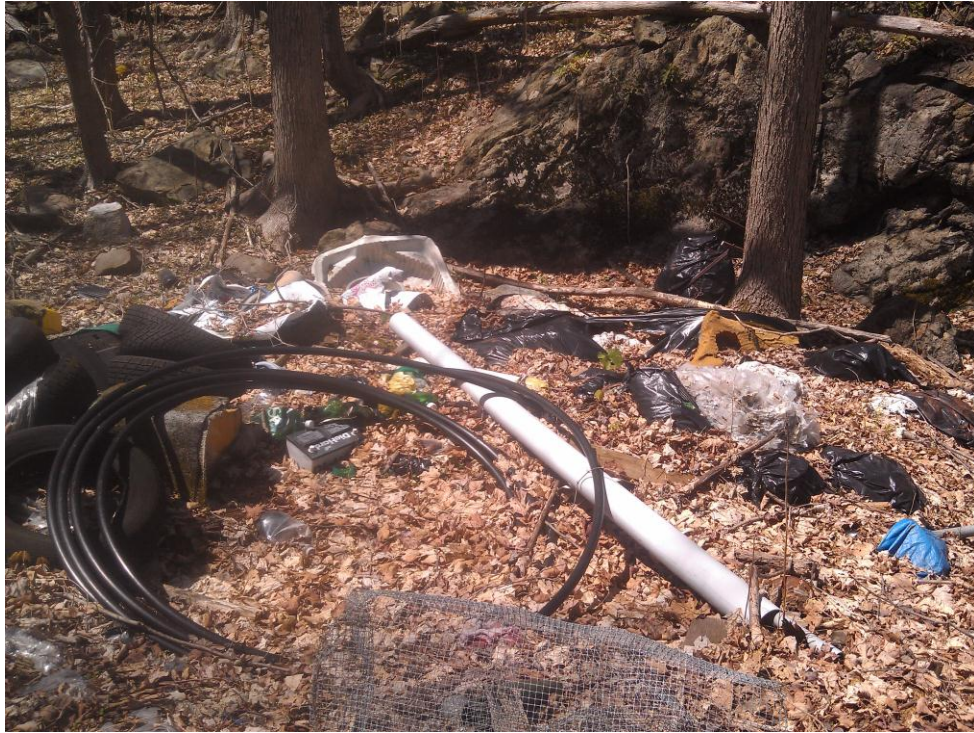
Photograph 27: Debris pile #1, containing tires, black flexible pipe, plastic debris, and bagged waste south of Caruso residence along northern perimeter of Parcel #2. View from southeast to northwest.

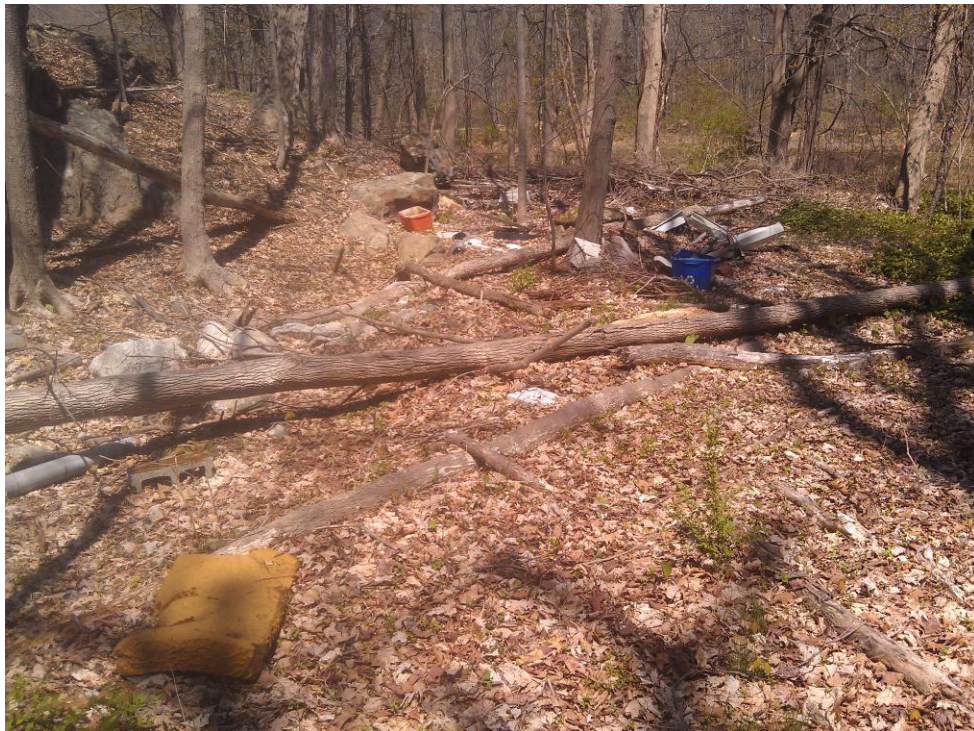
Photograph 28: Debris pile #1, containing miscellaneous debris south of Caruso residence along northern perimeter of Parcel #2. View from southwest to northeast.

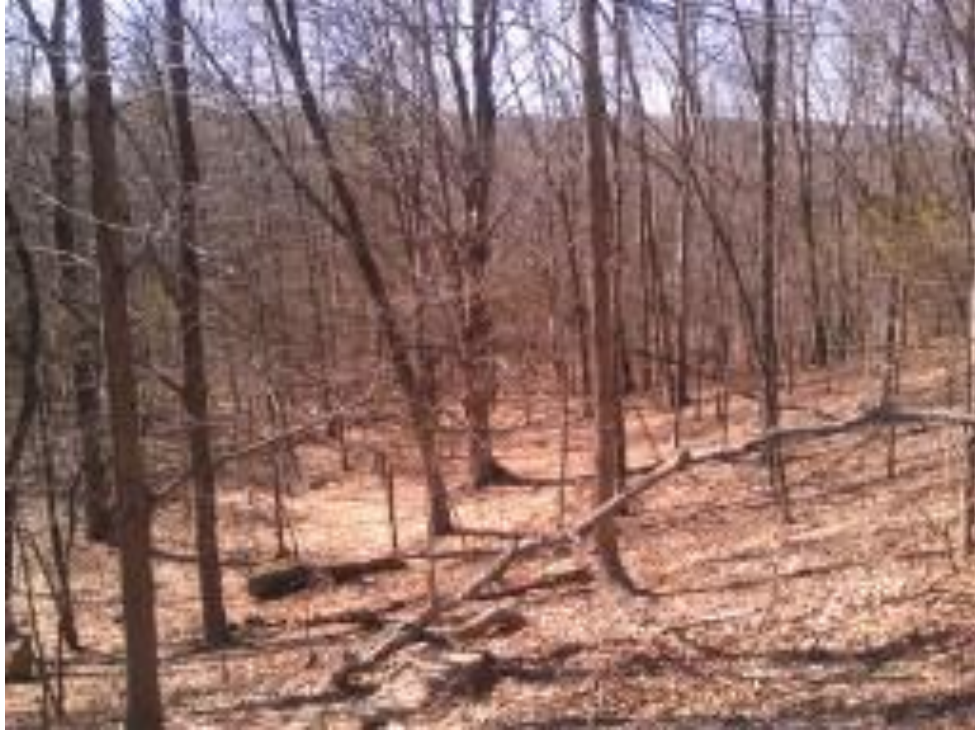
Photograph 29: Vacant, wooded area (Parcel #2). View from east to west.

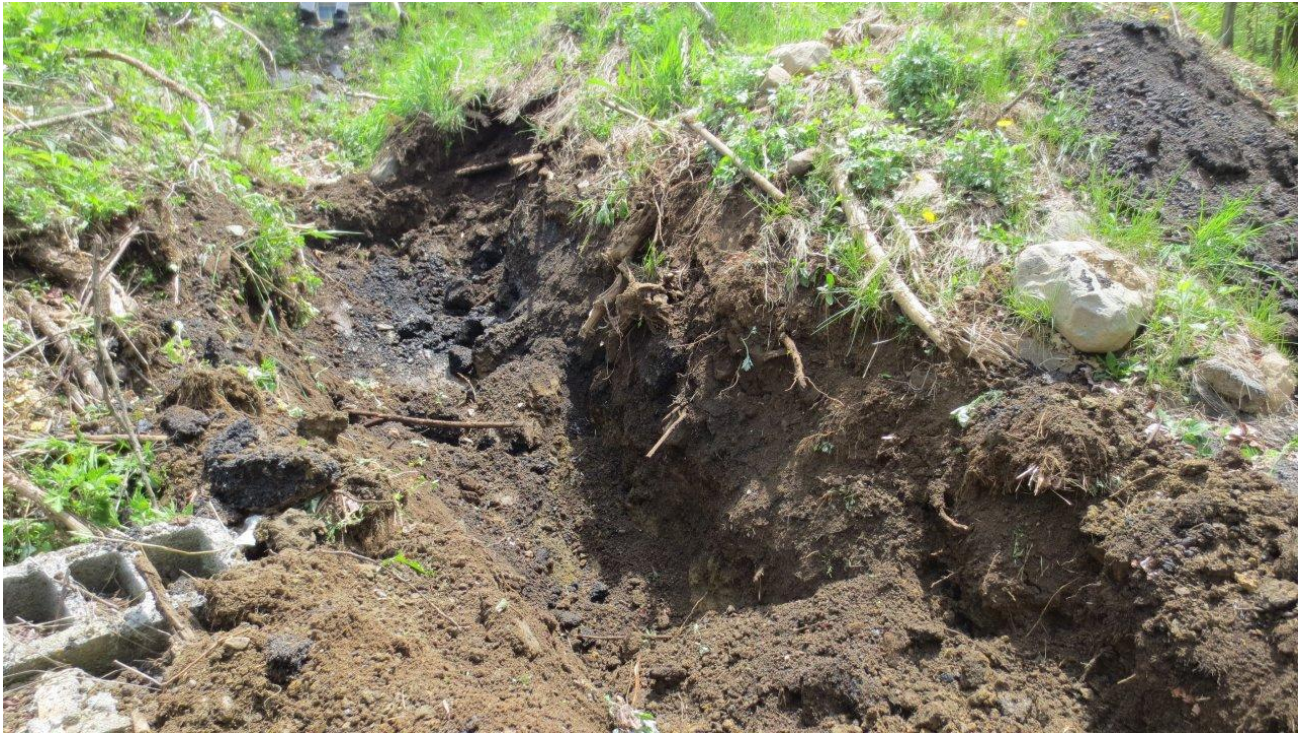
Photograph 1: View of the dirt, stone, and asphalt observed at TP-1.

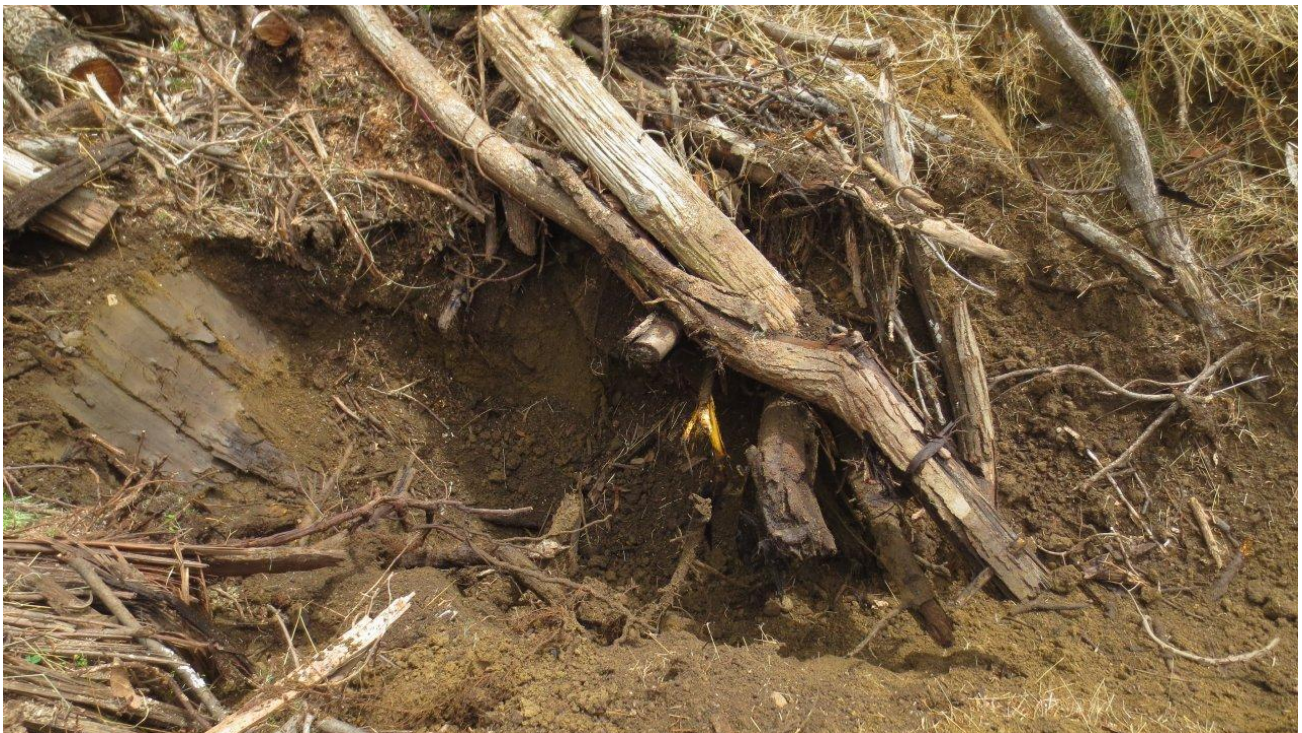
Photograph 2: View of the logs and tree debris observed at TP-2.

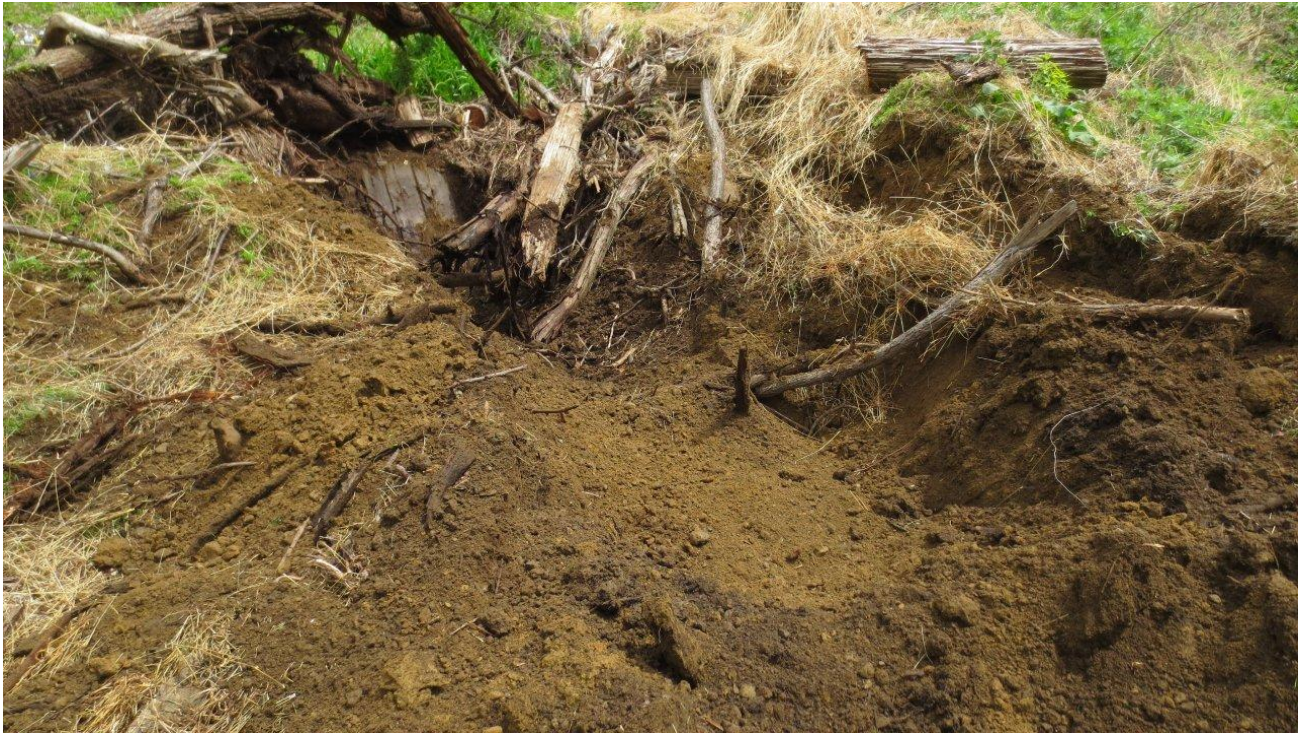
Photograph 3: Additional view of the tree debris observed at TP-2.
