APPENDIX A
PHOTOGRAPHS

APPENDIX A-1
PHASE I ESA PHOTOGRAPHS

APPENDIX A-2
TEST PIT INVESTIGATION PHOTOGRAPHS
(MAY 13, 2014)

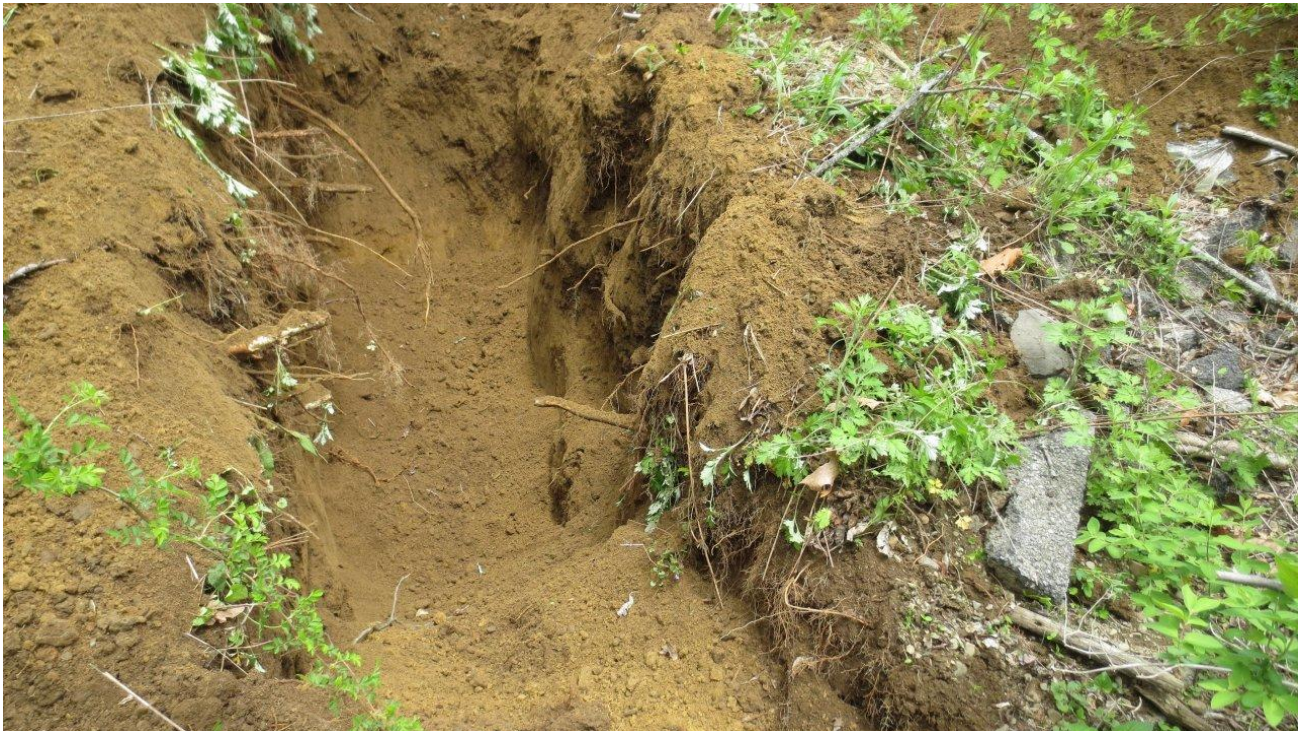
Photograph 4: View of surficial asphalt (right), dimensional lumber, and native soils observed at TP-3.

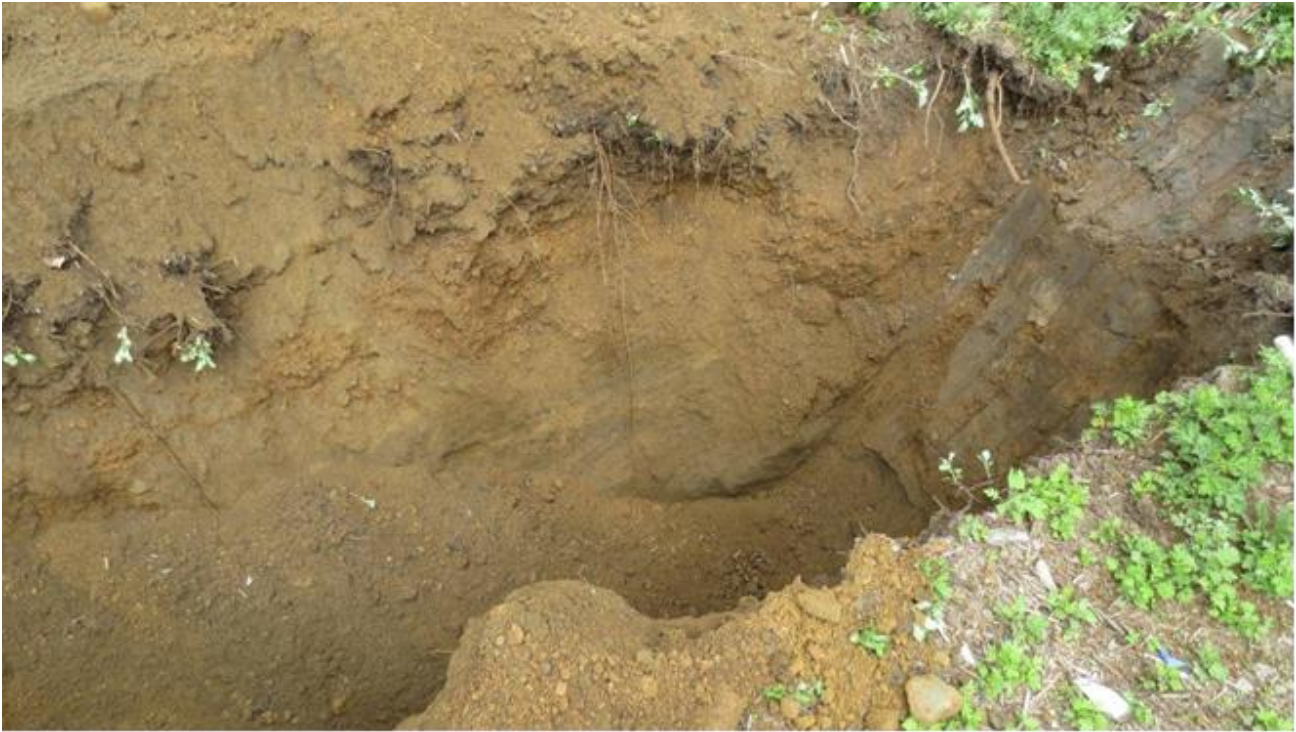
Photograph 5: View of the native sand observed at TP-4.

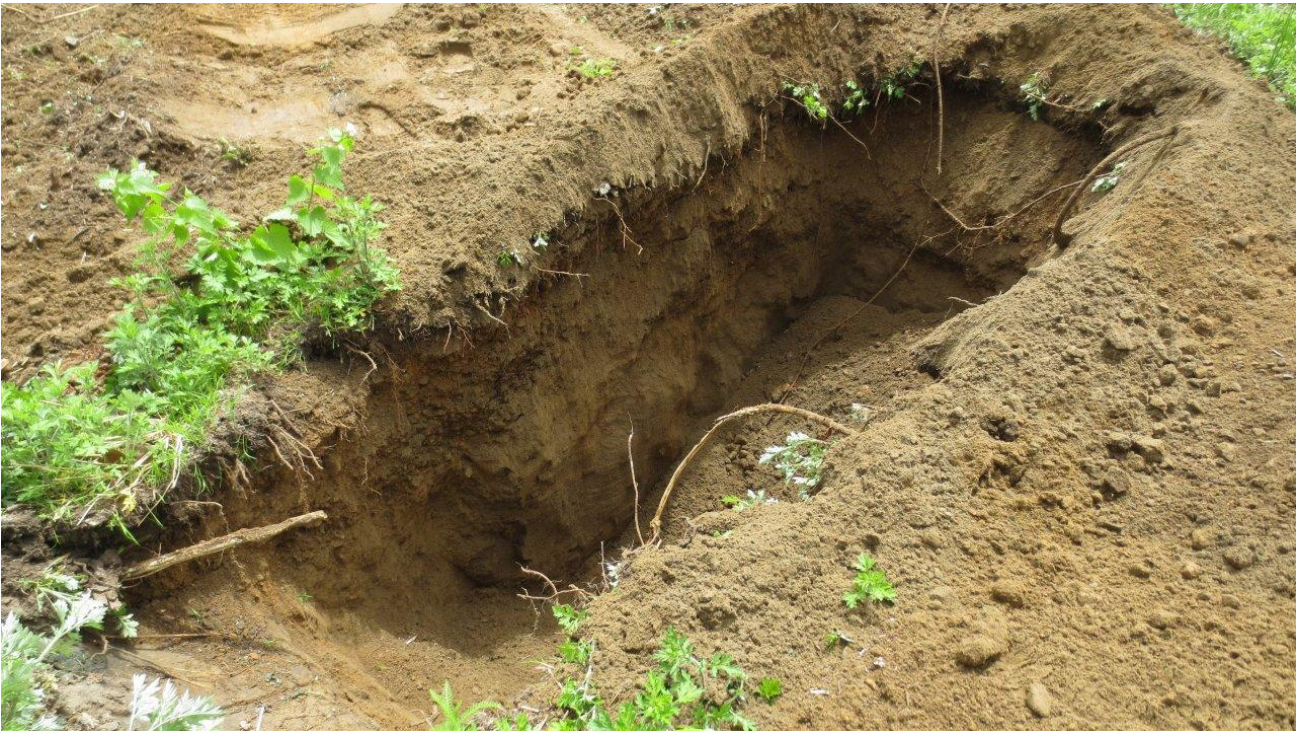
Photograph 6: View of the native sand observed at TP-5

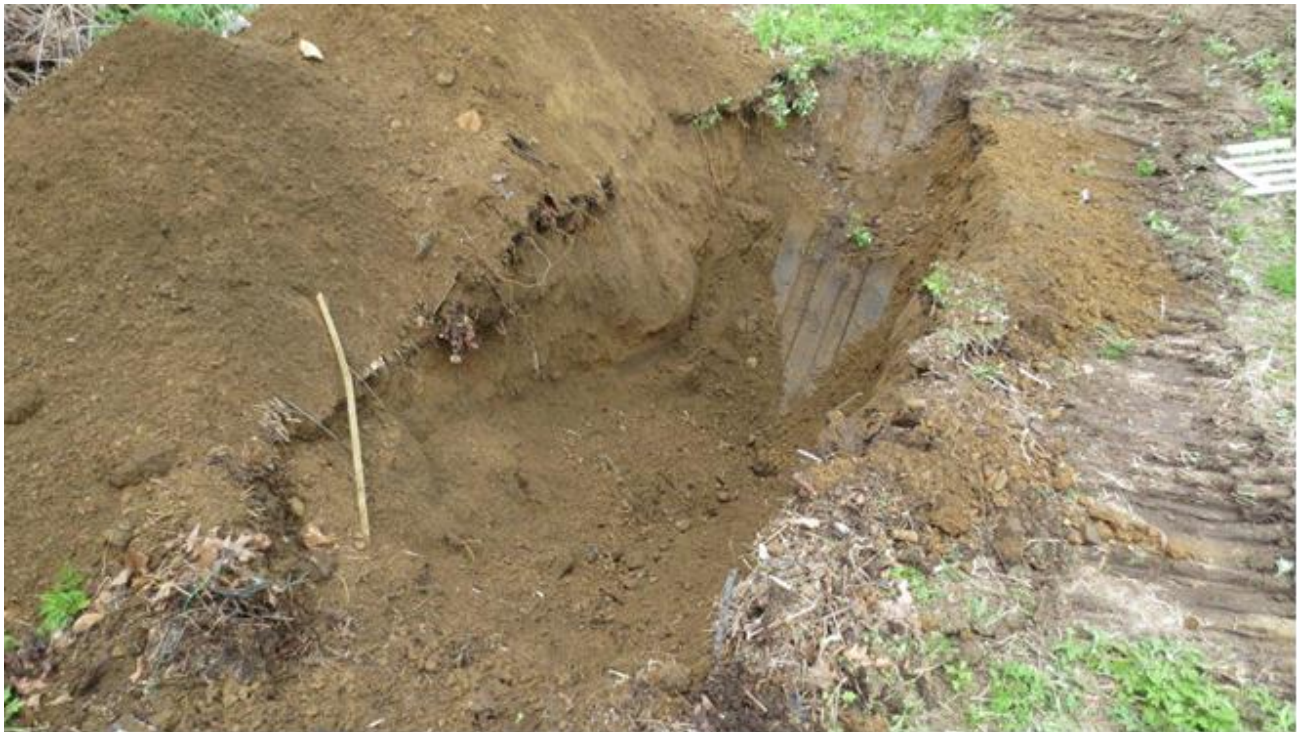
Photograph 7: View of the native sand observed at TP-6.

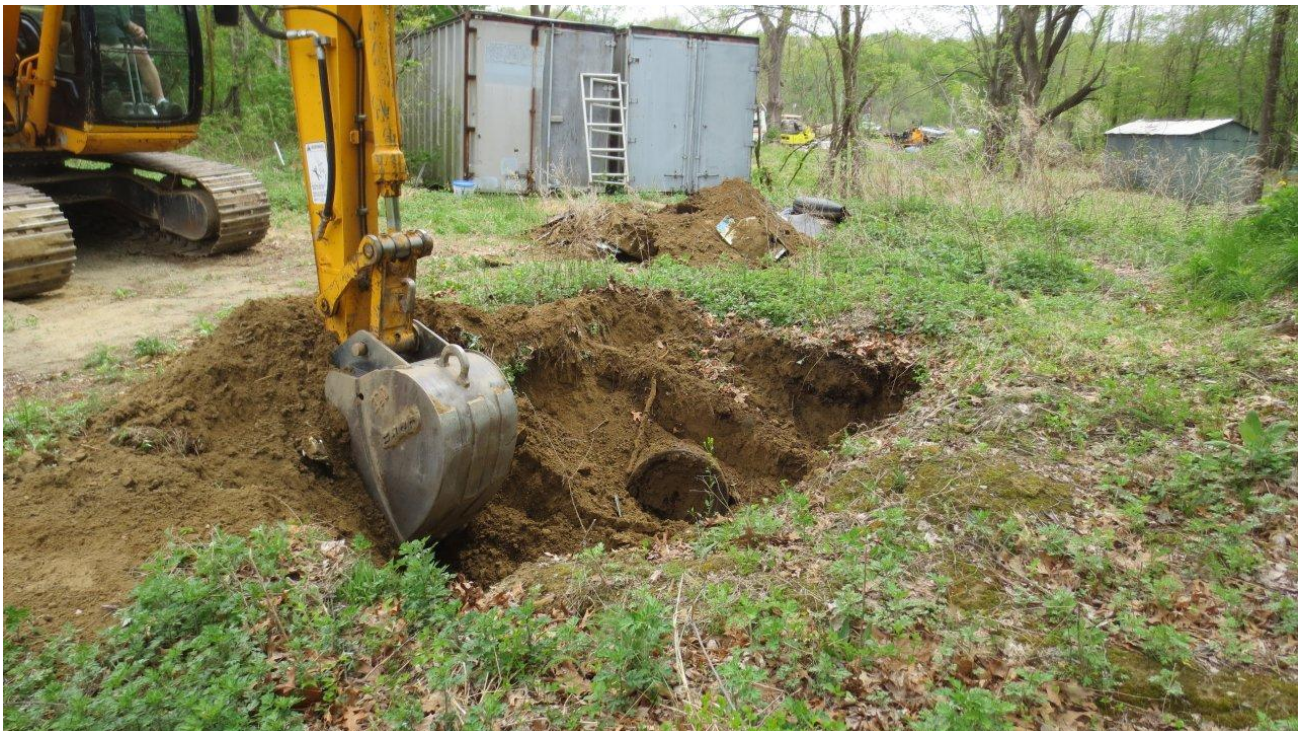
Photograph 8: View of the excavation of TP-7, facing east.

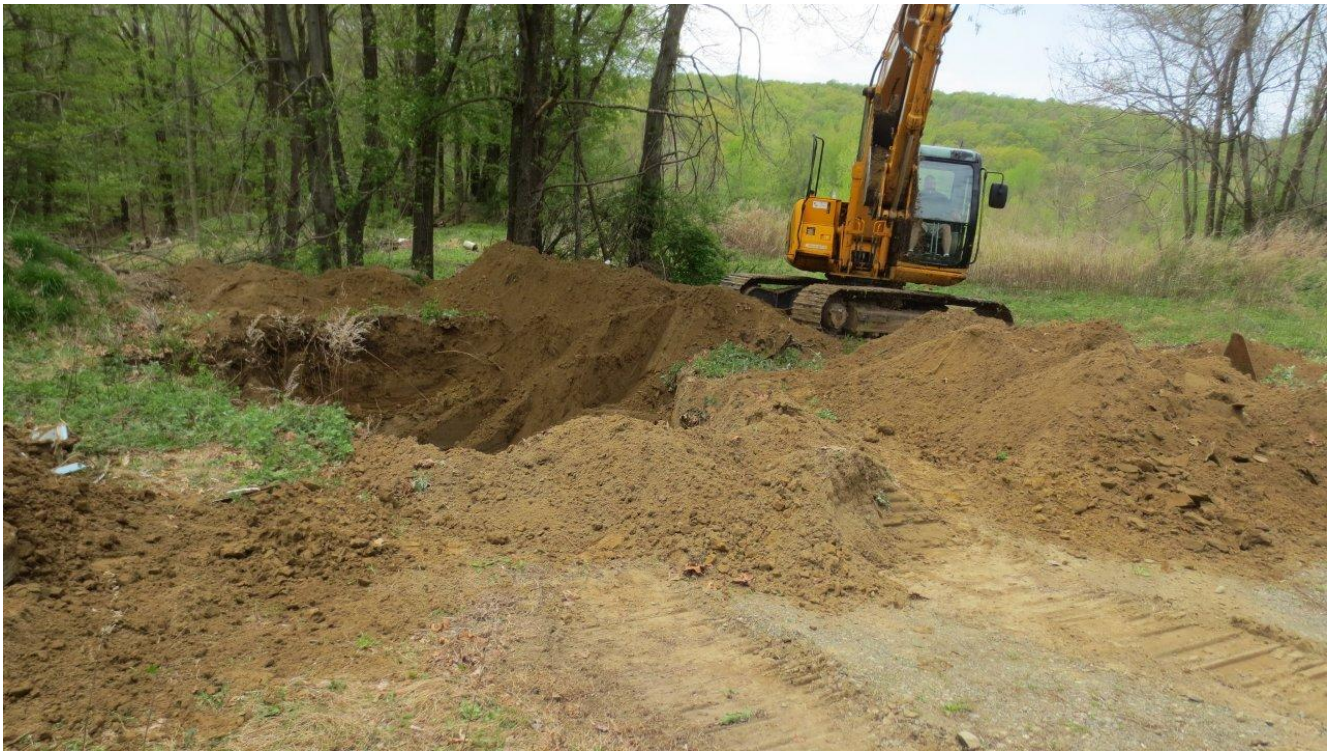
Photograph 9: View of the material excavated from TP-7, facing west.

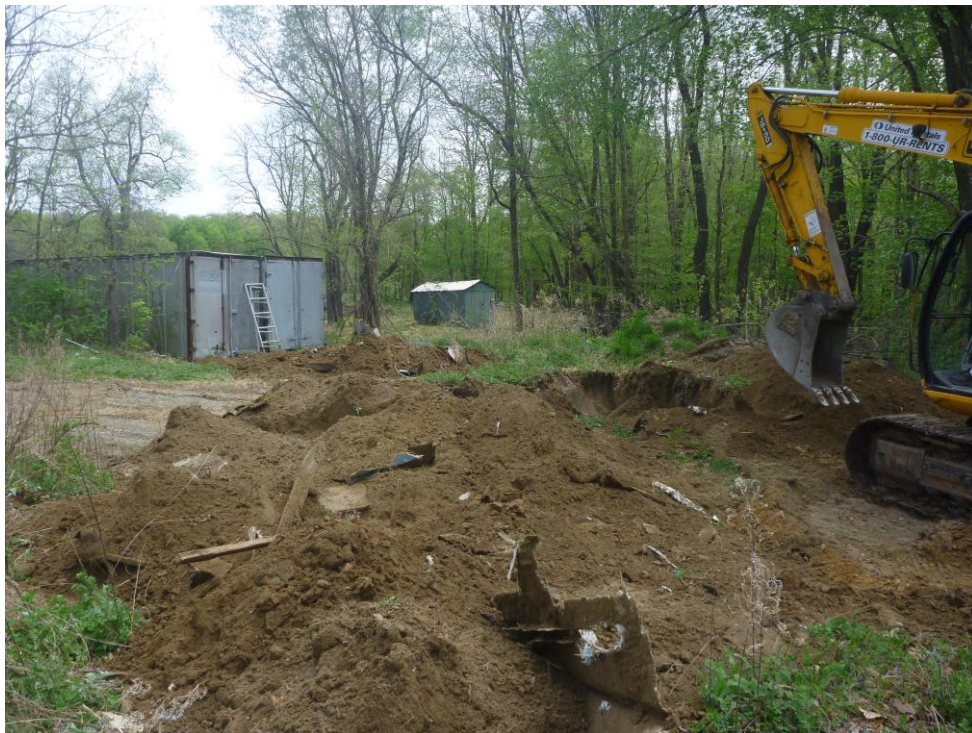
Photograph 10: View of a portion of the boat debris recovered from TP-7.

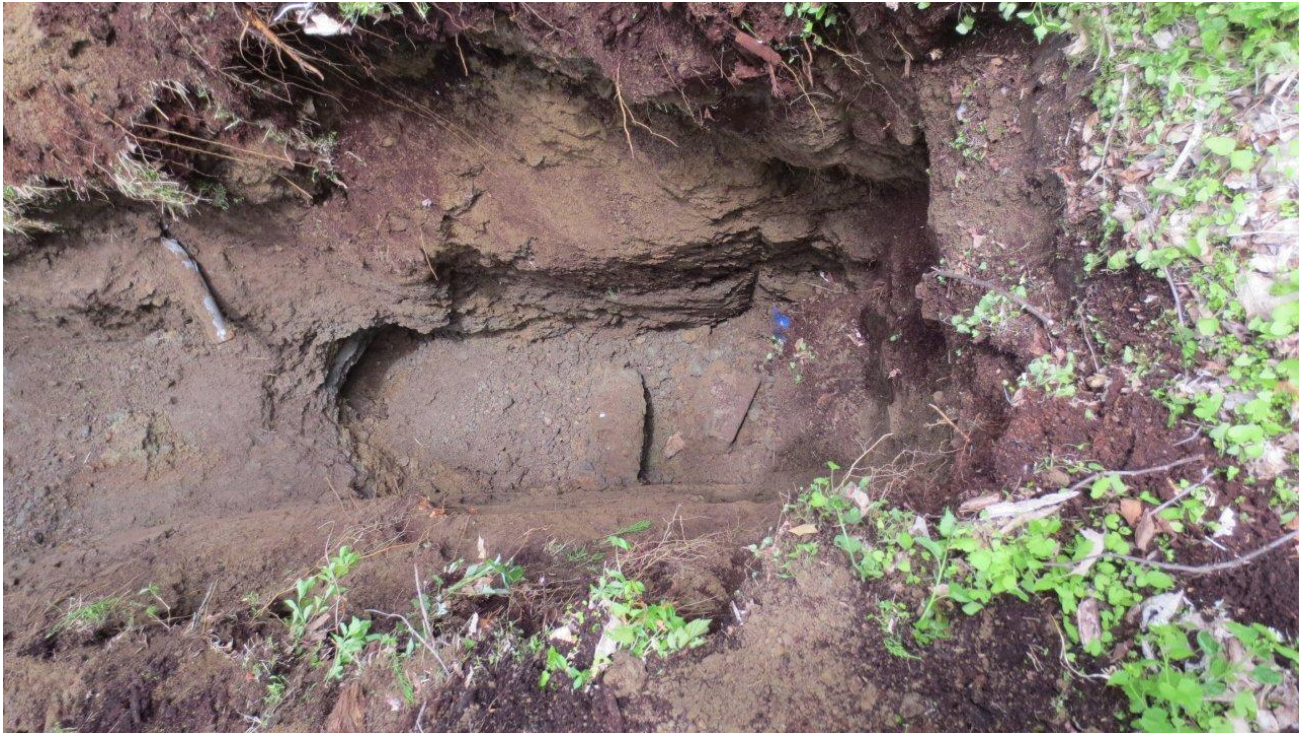
Photograph 11: View of the plastic conduit (left) and organic soil observed at TP-8.

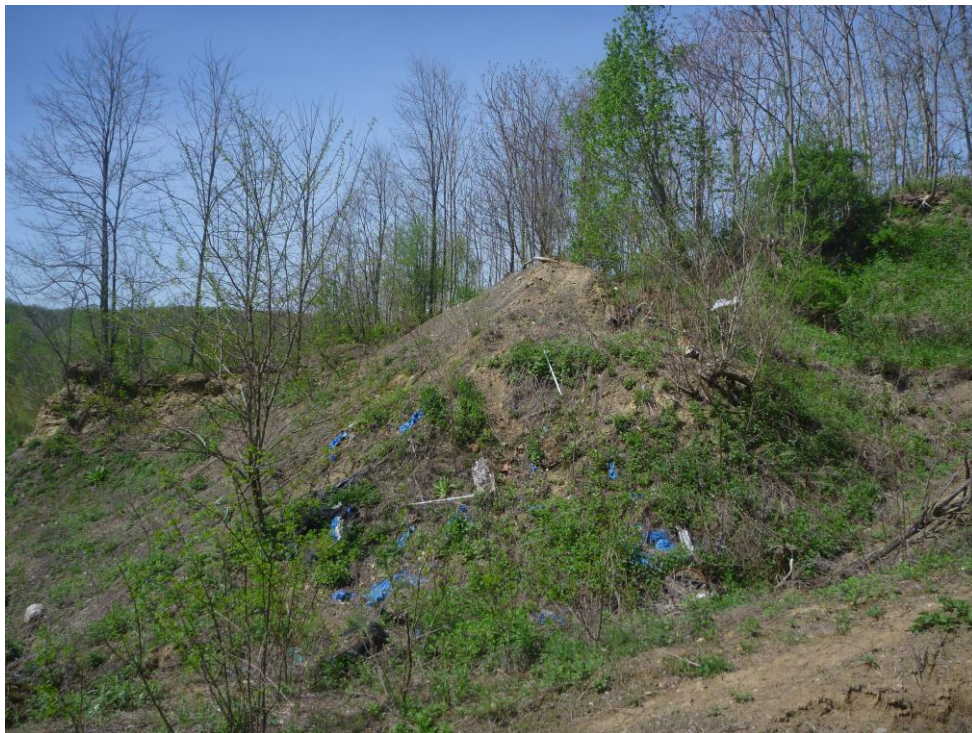
Photograph 12: View of the debris observed on the surface of TP-9

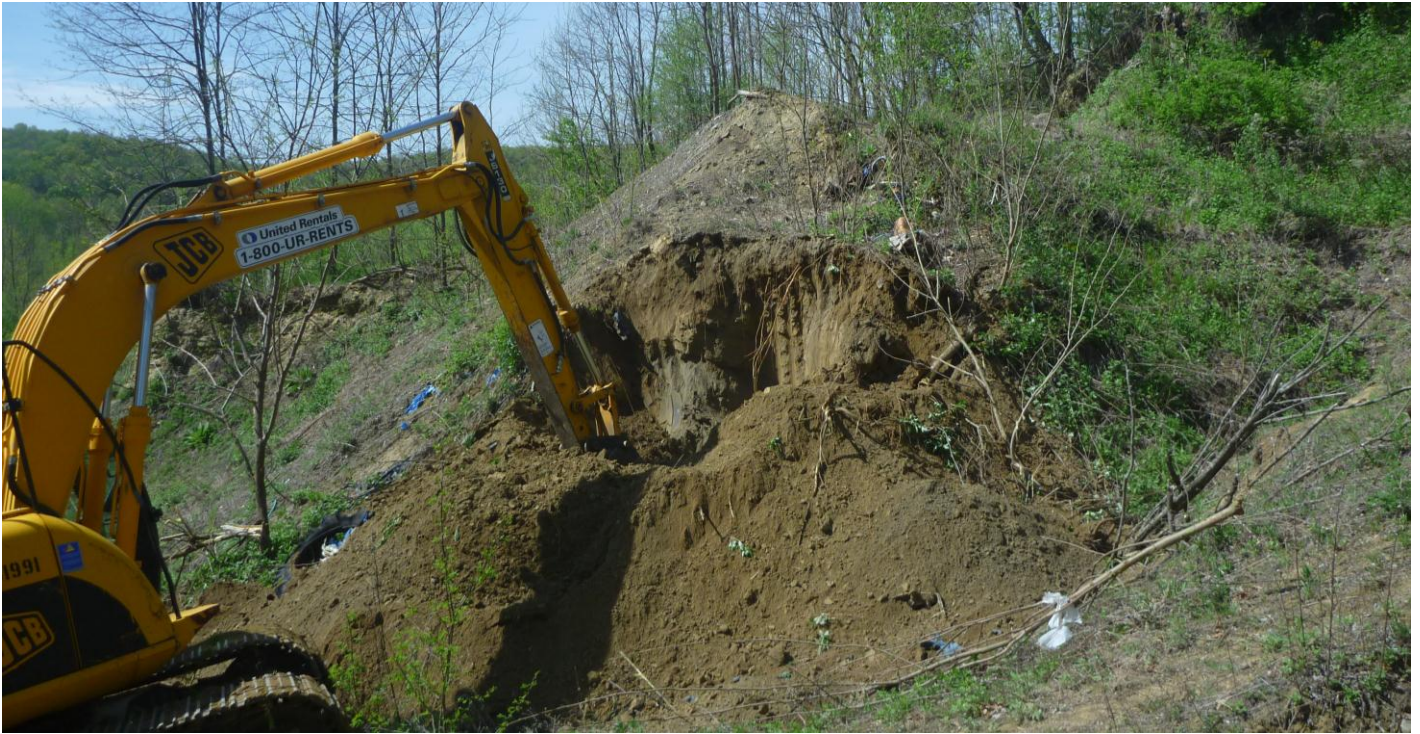
Photograph 13: View of the clean sand observed at TP-9
