SITE INVESTIGATION
For
WETLANDS and WATERS of the U.S.

For
TRADITIONS RESORT & CASINO
PROJECT AREA

May 12, 2014

Revised June 26, 2014

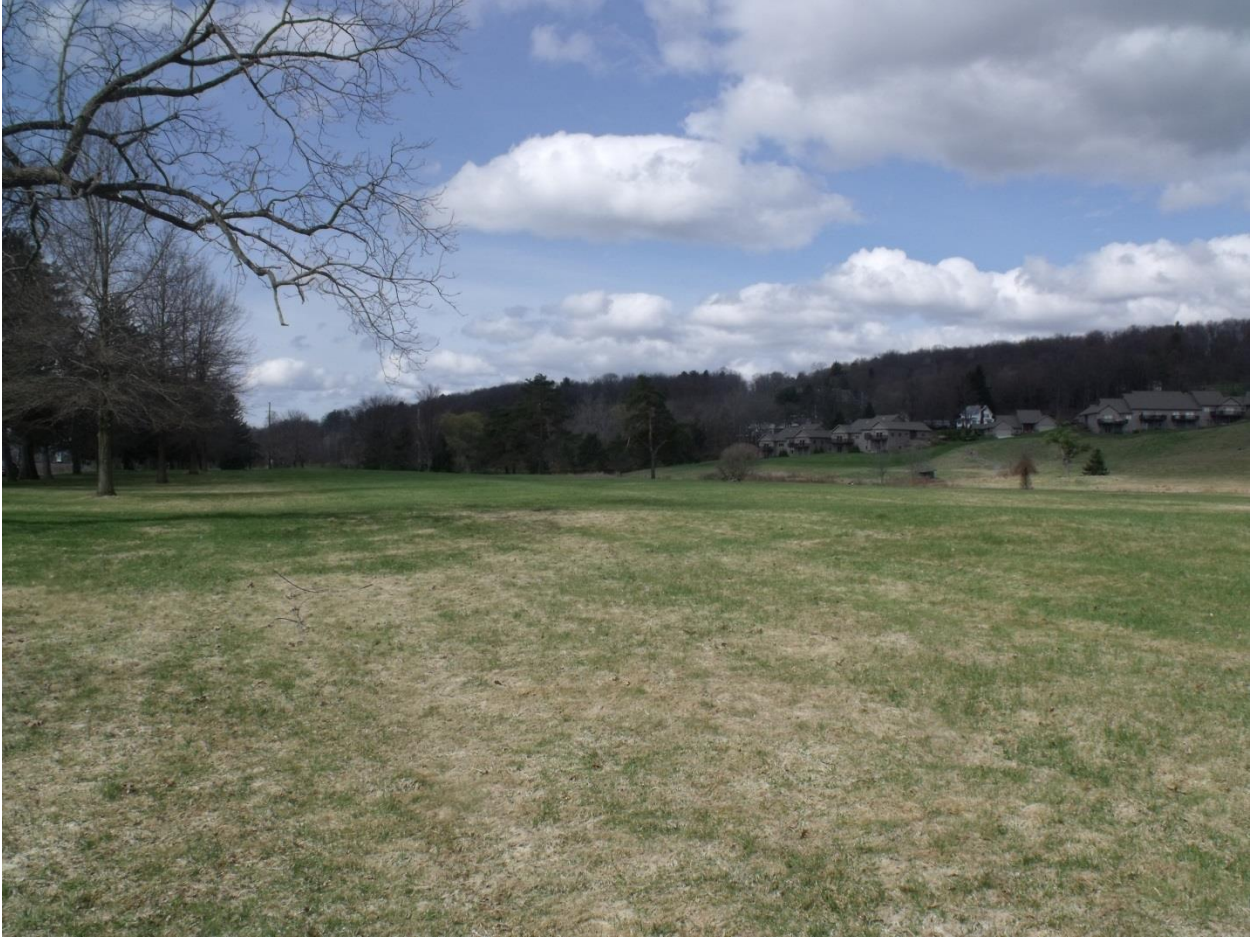
Photograph 1. This area is next to Watson Blvd. The photograph was taken looking west from the approximate location of the new proposed entry road. The soils are Unadilla silt loam. This is an upland area.

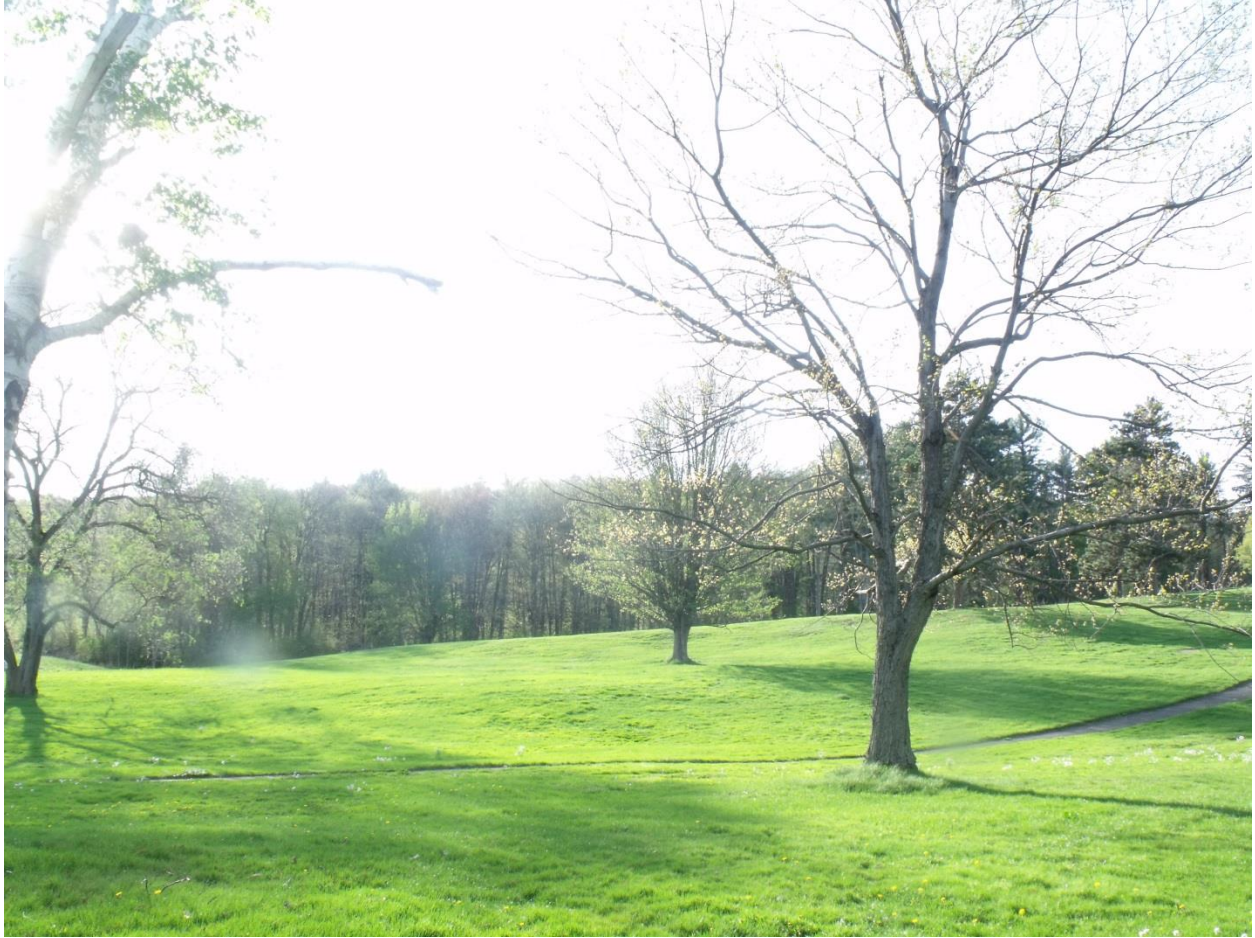
Photograph 2. This photograph is looking northwest across former fairways toward wooded area west of hotel. Soils are Unadilla silt loam (5-15% slope). This is an upland area.

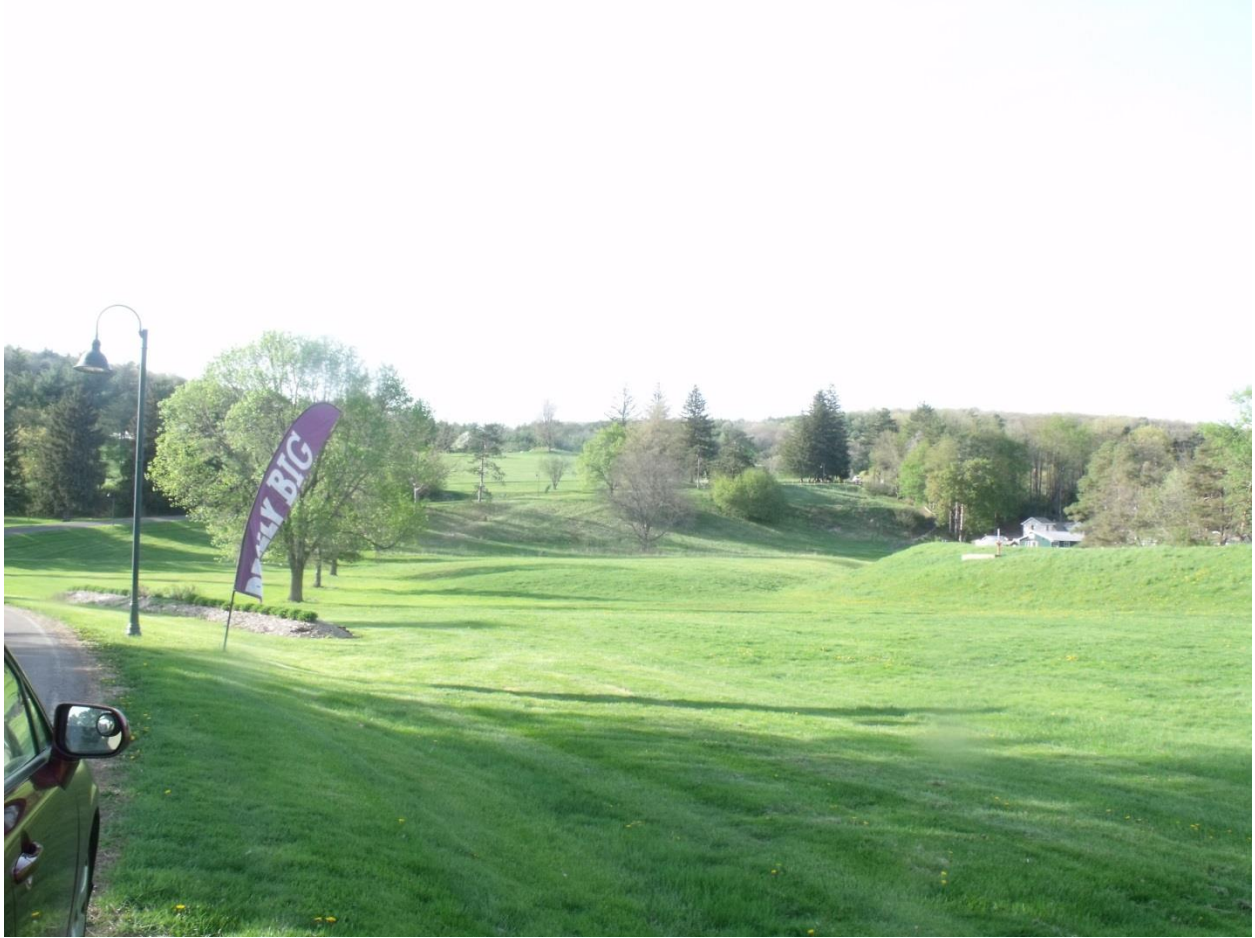
Photograph 3. Photograph taken looking north along east side of entry road. The area is a former golf course fairway. Soils are Unadilla silt loam and Middlebury soil. This area in the foreground will not be impacted by the project. The area on the hillside (background) will be part of the project. This is an upland area.

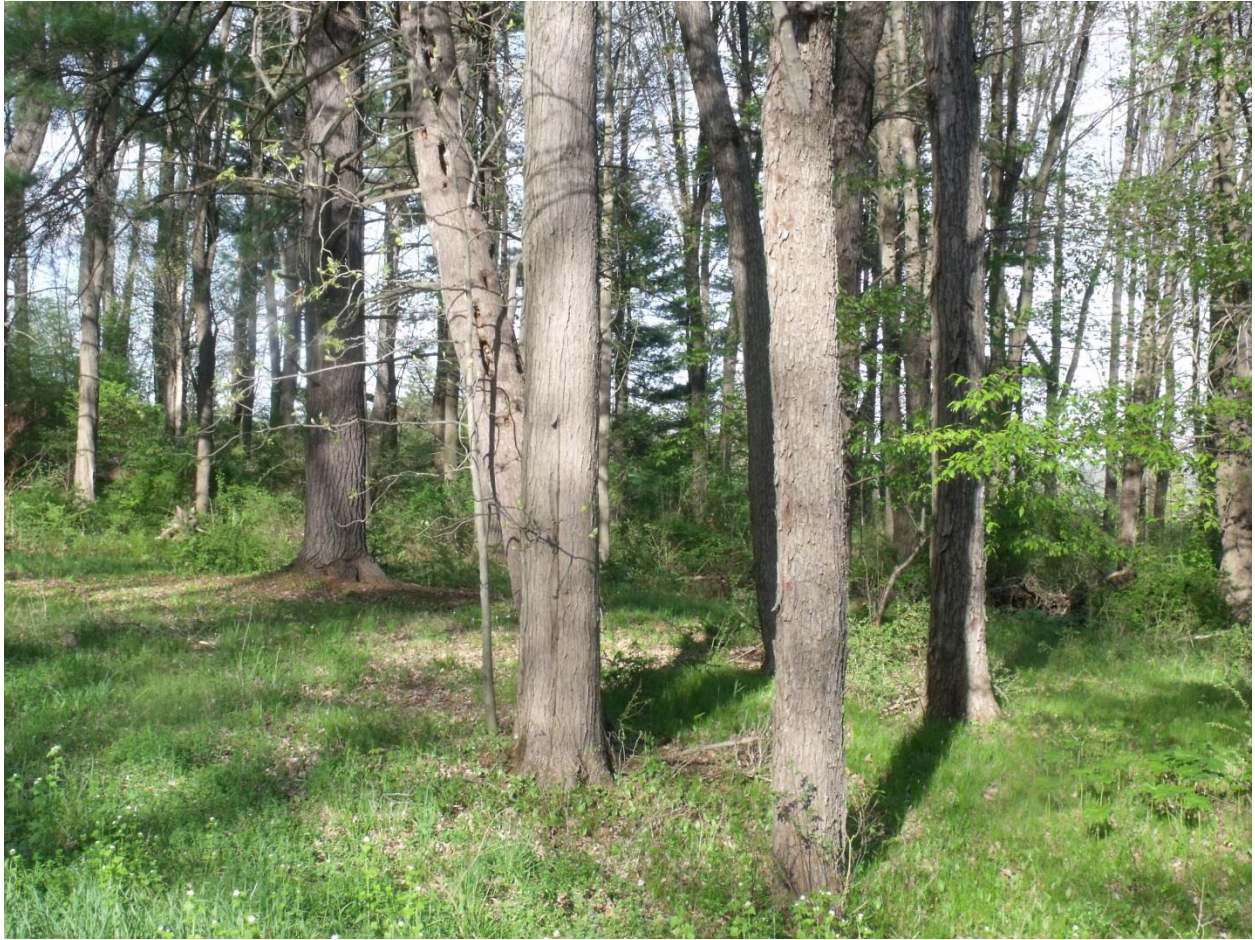
Photograph 4. Photograph taken looking south into wooded area to be cleared for parking. This is a typical northeast forest area. The trees are primarily white pine (*Pinus strobus*), white ash (*Fraxinus Americana*), red oak (*Quercus rubra*) and red maple (*Acer rubrum*). Seen in the herbaceous understory on the right side of the photograph are mayapples (*Podophyllum peltatum*). These plants are upland species (Facu) except for the red maple which is fac6. This area is an upland.
