Memorandum

To: Nicole Emmons (HH)
From: Jim Nash (AKRF)
Date: August 10th, 2012
Re: EPT Concord Resort – Resort Entry Road investigation area – Wetland Delineation
cc: C. Robbins (AKRF), N. Bourne (AKRF)

Summary:

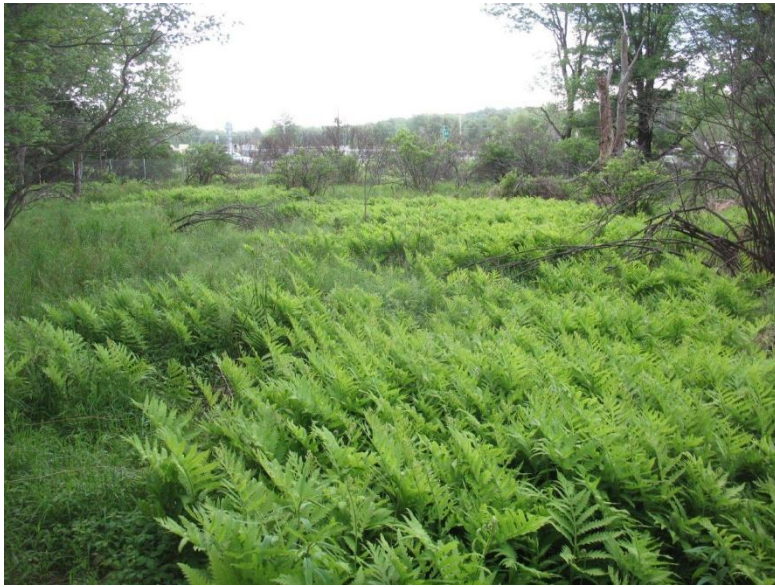
Photograph 1: Emergent/Shrub Scrub Portion of wetland – Rte 17 visible.

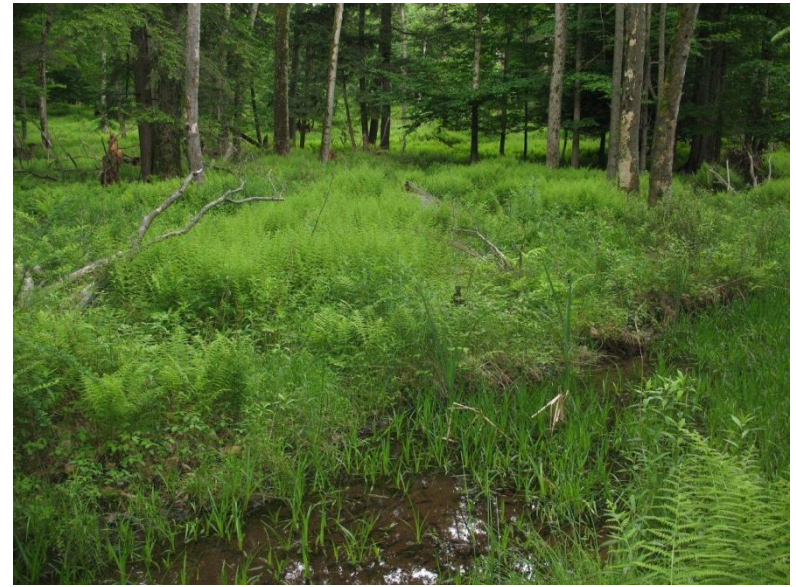
Photograph 2: Emergent portion of delineated wetland.

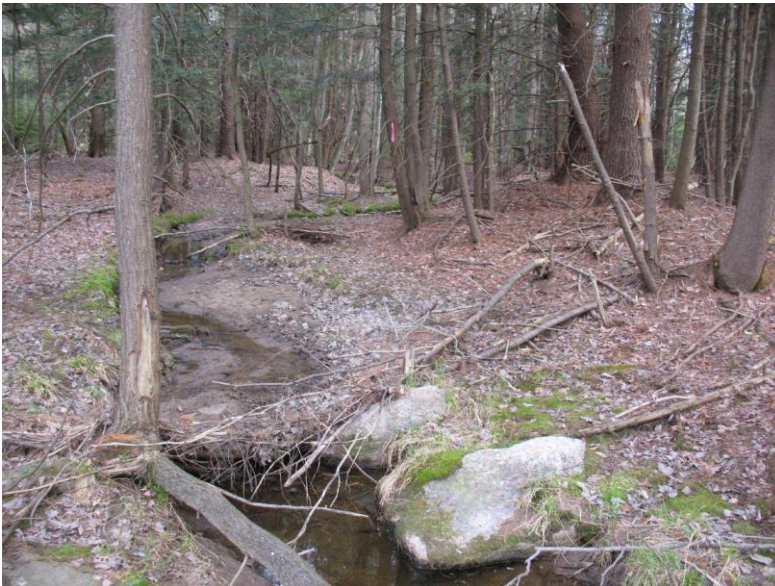
Photograph 3: Hemlock dominant portion with meandering stream.

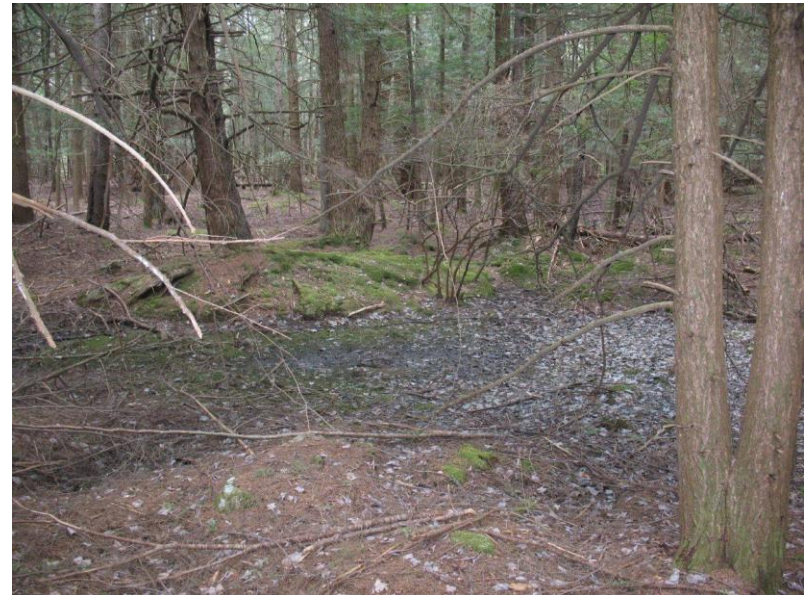
Photograph 4: Typical pit/mound topography in hemlock wetland.
