Memorandum

To: Nicole Emmons (HH)
From: Jim Nash (AKRF)
Date: August 10, 2012
Re: EPT Concord Resort – STP investigation area - Wetland Delineation
cc: C. Robbins (AKRF), N. Bourne (AKRF)

This memorandum presents the results of a wetland delineation conducted by AKRF on June 7th, 2012 at the site of the STP connection for the EPT Concord Resort project.

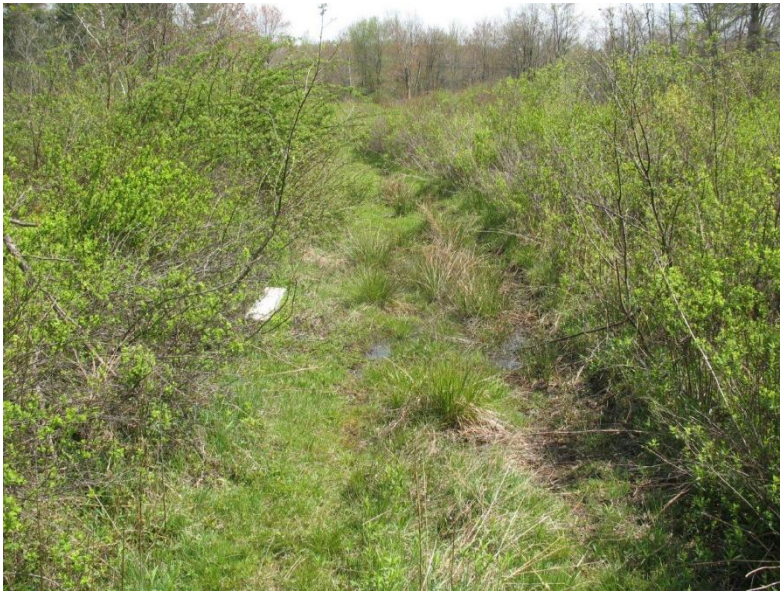
Photograph 1: Portion of access roadway – showing wetland area.

Wetland portions of the roadway contain patches of sedge/rush species including broom sedge (*Carex scoparia*) FACW, soft rush (*Juncus effusus*) FACW+, fox sedge (*Carex vulpinoidea*) OBL, and dark green bulrush (*Scirpus atrovirens*) OBL. Additional species identified in wet portions of the roadway include marsh bedstraw (*Galium palustre*) OBL, reed canarygrass (*Phalaris arundinacea*) FACW+, swamp dewberry (*Rubus hispidus*) FACW, and deertongue grass (*Panicum clandestinum*) FAC+. Soils meet hydric soil indicator F3: Depleted Matrix (typically 0-6” 7.5YR 4/2; 6-10 7.5 YR 4/2 with 5/6 mottles >10%). Saturated soil, small areas of ponding, and oxidized rhizospheres were observed hydrology indicators.

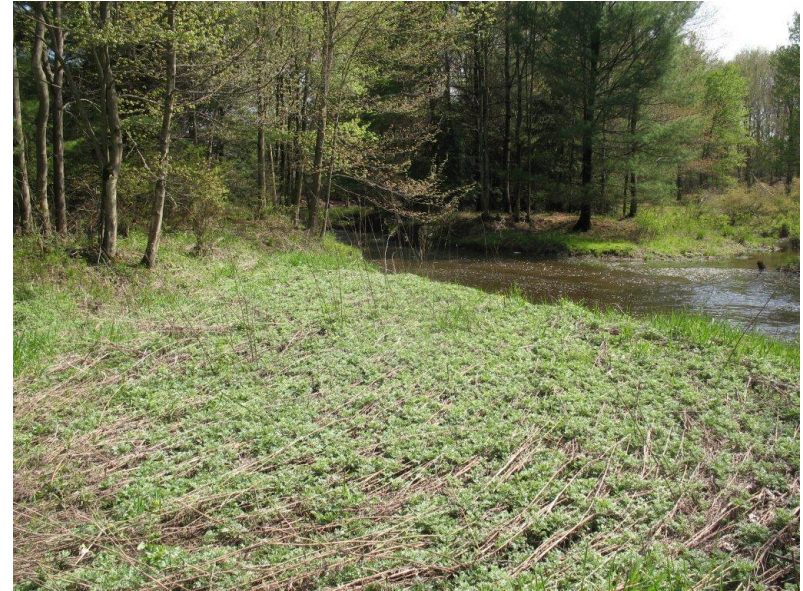
Photograph 2: Floodplain of adjacent streamcourse – at confluence of Kiamesha Creek/Tannery Brook.

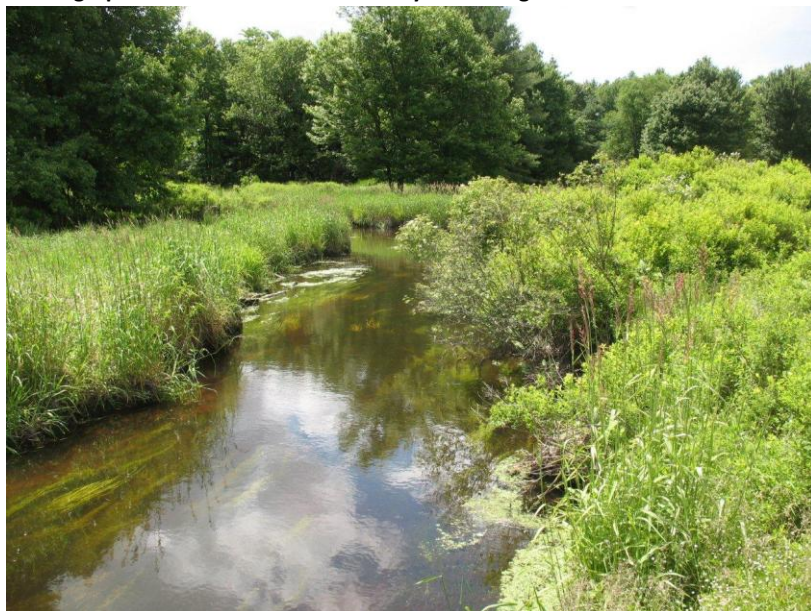
Photograph 3: Stream (Tannery Brook) adjacent to dirt/grass roadway.

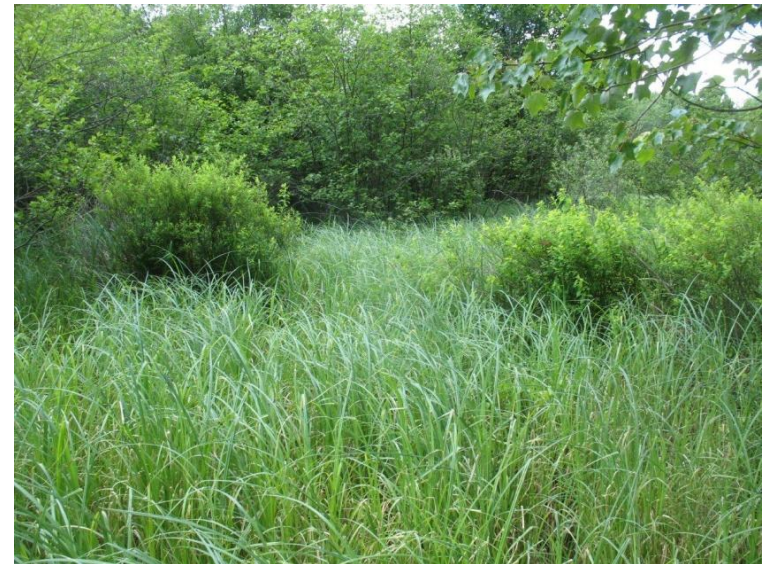
Photograph 4: Typical scrub-shrub of DEC Wetland MO-56.

The onsite wetland that surrounds the roadway is a diverse floodplain wetland with forested, scrub/shrub and emergent/graminoid portions. Immediately beyond the confines of the roadway such species as speckled alder (*Alnus rugosa*) FACW+, broadleaf meadowsweet (*Spirea latifolia*) FAC+, silky willow (*Salix sericea*) OBL, tussock sedge (*Carex stricta*) OBL, highbush blueberry (*Vaccinium corymbosum*) FACW, and sensitive fern (*Onoclea sensibilis*) FACW occur.
