SITE INVESTIGATION
For
WETLANDS and WATERS of the U.S.

For
TRADITIONS RESORT & CASINO
PROJECT AREA

May 12, 2014

Revised June 26, 2014

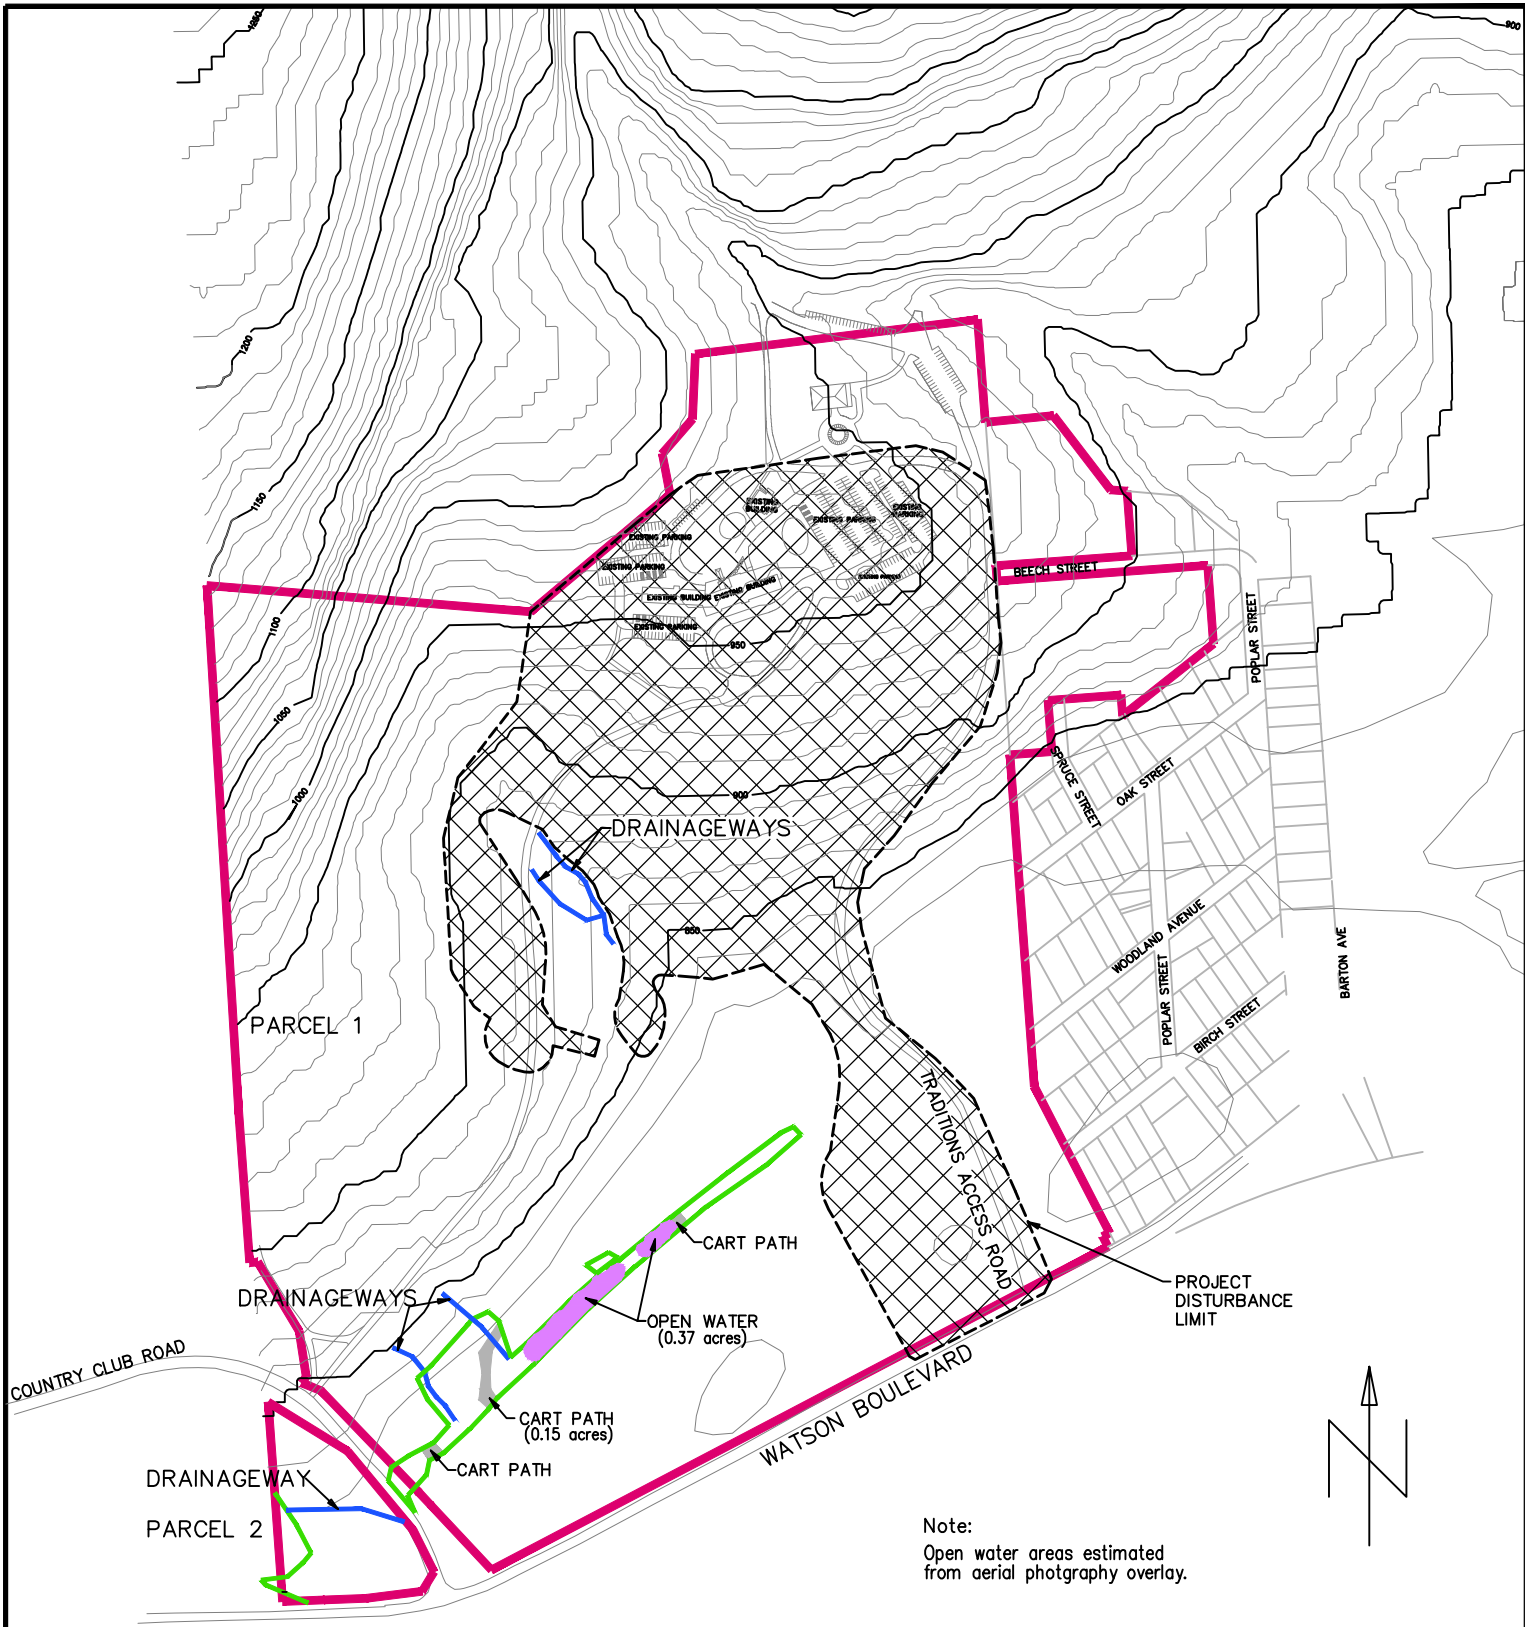
FIGURE NO.

The potential jurisdictional areas previously identified (2005) and confirmed during this field investigation will not be impacted by the planned project. Based on the results of the available information search, the site inspection and the survey, no areas within the project area (see attached Figure 1) demonstrate the criteria to be considered as jurisdictional wetlands or waterways.
