**REMEDIAL INVESTIGATION REPORT
OPERABLE UNIT 1A**

**Concord Hotel and Resort
Brownfield Cleanup Program Site #C353008
Town of Thompson, Sullivan County, New York**

**SESI CONSULTING ENGINEERS, P.C.
12A Maple Avenue
Pine Brook, NJ 07058**

Project No.: N-7180

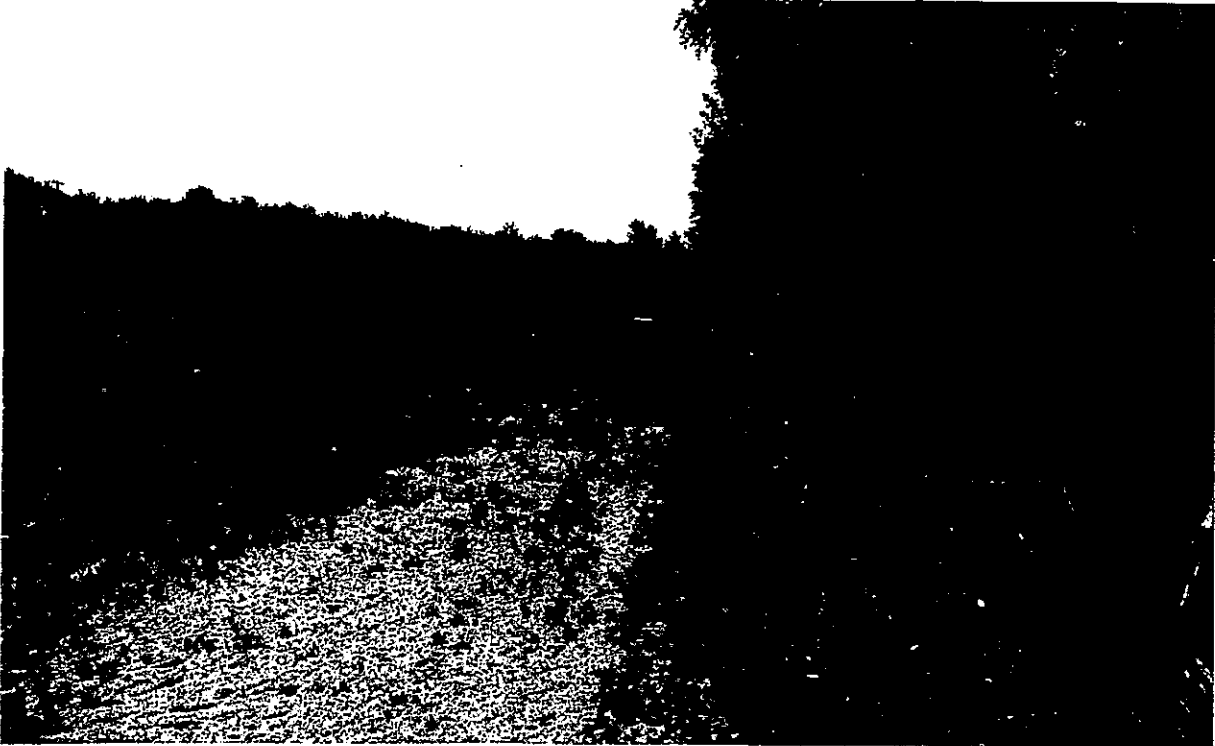
Photo # 6: Looking South at western edge of the redevelopment area, about 800-feet west of OU1A. Settling basin and silt fence have been constructed at woodland/wetland boundary to protect against runoff into Kiamesha Lake.
