## **DESCRIPTION OF LAND**

### **Exhibit VIII. C.1.e**

#### **Floodplain Areas**

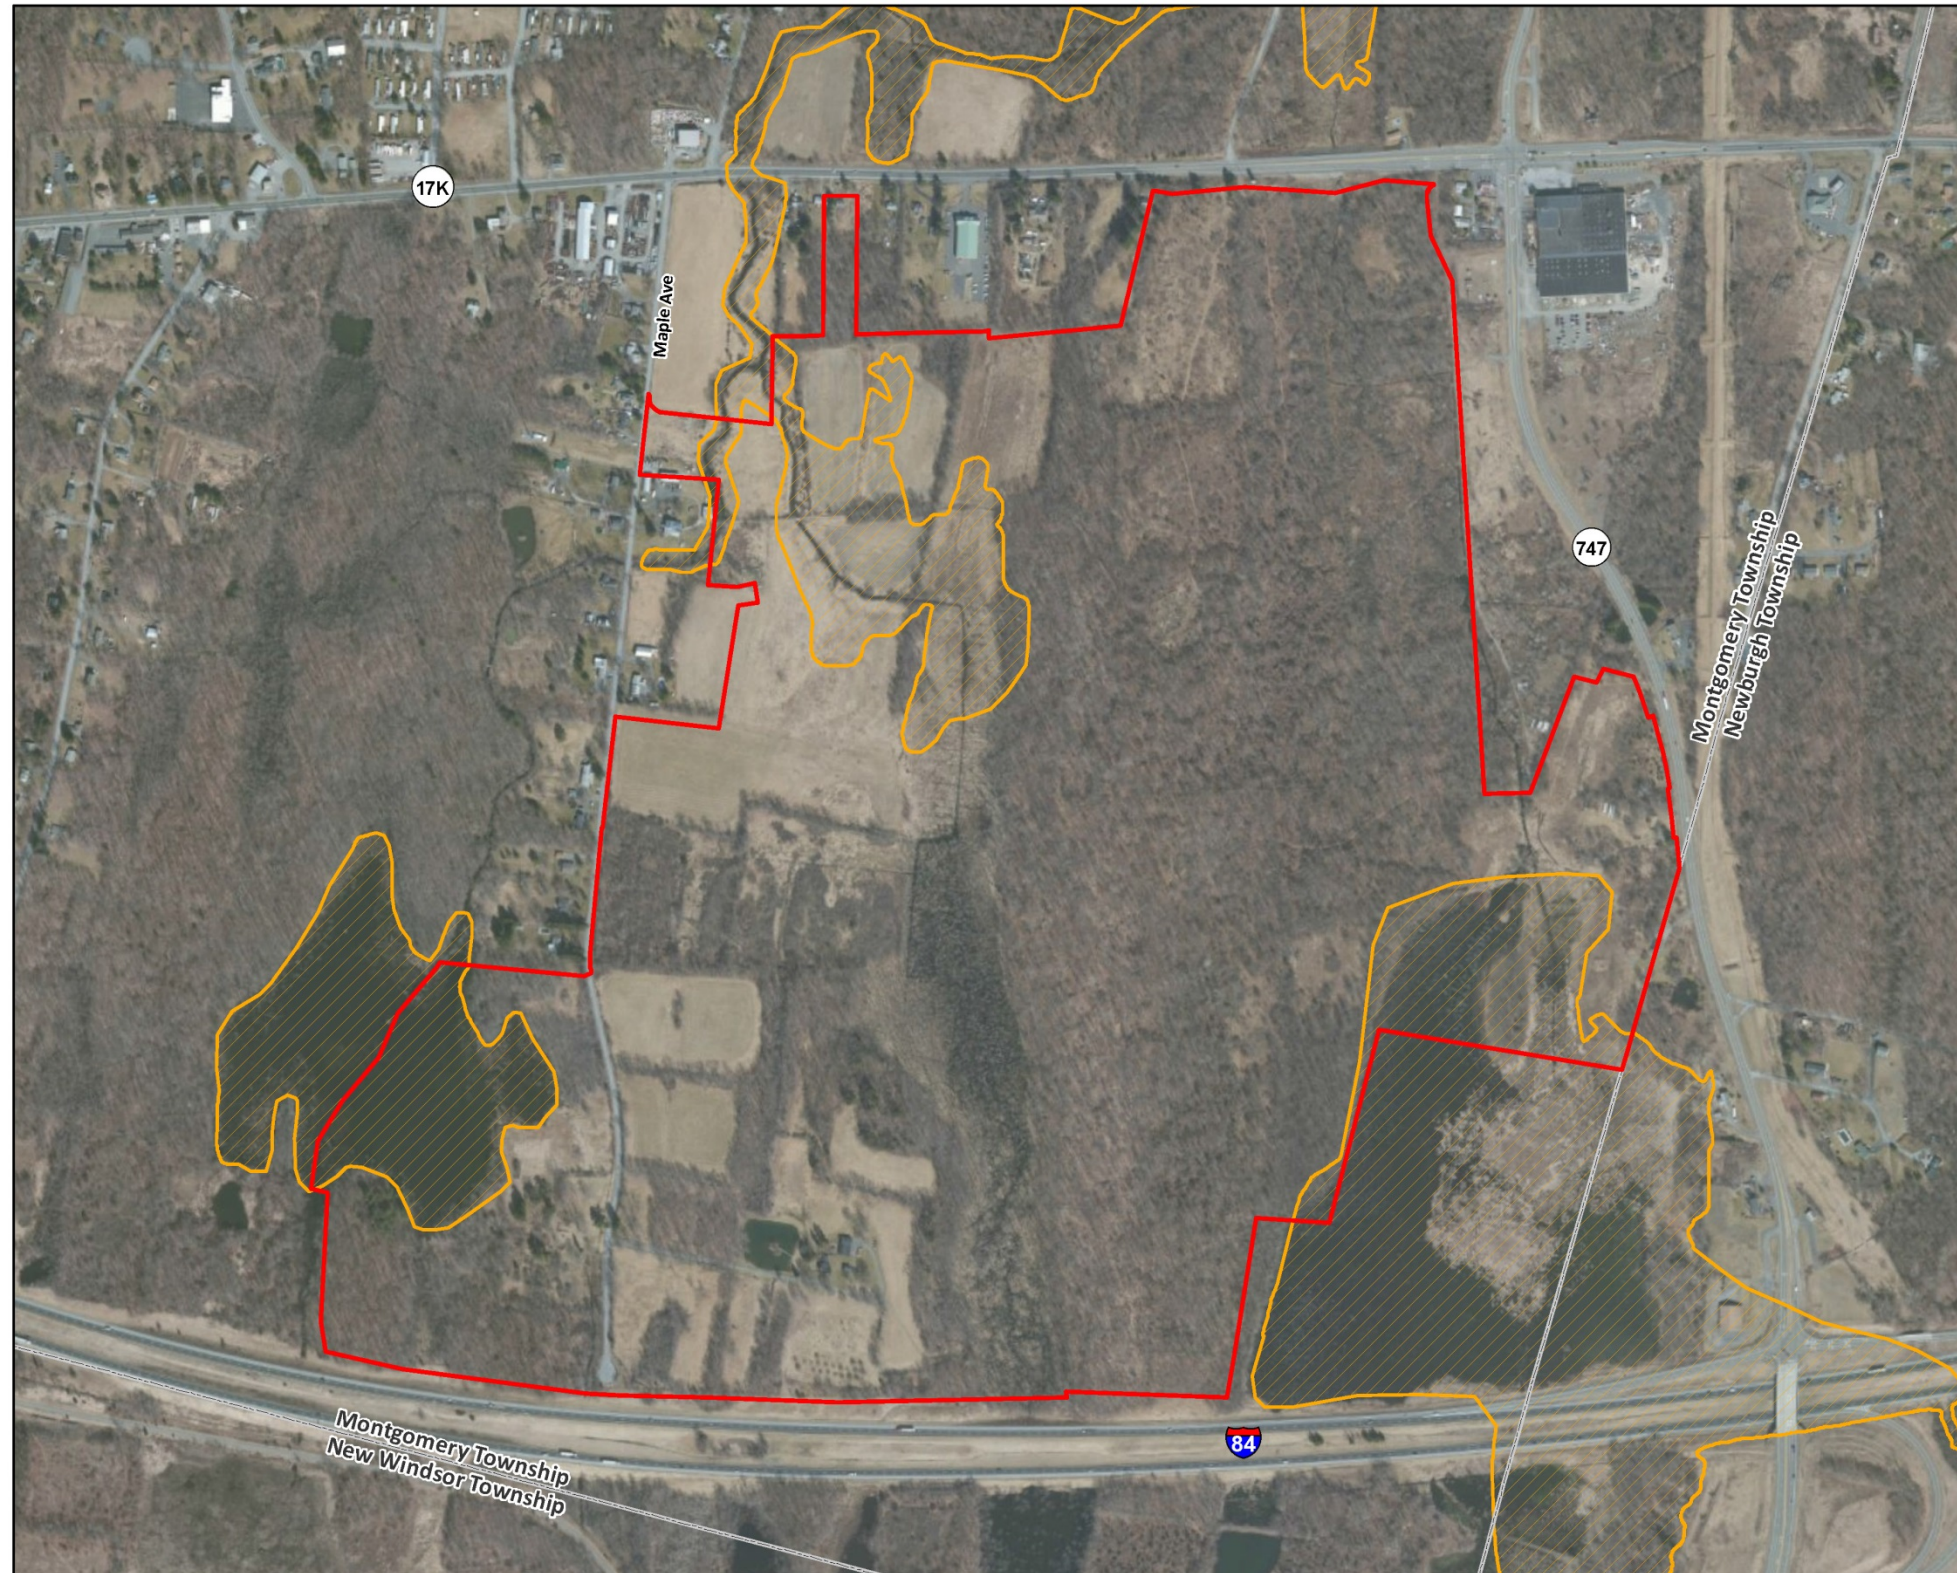
Figure VIII. C.1.e-1. Flood Plains

<b>Resorts World Hudson Valley</b>	
<b>Flood Plains</b> Montgomery Township Orange County, New York	
THE Louis Berger Group, INC.

According to the Federal Emergency Management Agency (FEMA), areas of the project site are located within the 100-year flood zone. These areas include a portion of Lot 95 in the northwest part of the site, a portion of Lot 75.2 in the southwest part of the site, and 14.6 acres of Lot 70.2. Approximately 46.9 acres of the project site lies within the 100 year floodplain. The site is not located within a floodway or a 500-year flood zone; see Figure VIII. C.1.e-1 FEMA Floodplains.
